Olympic View Transfer Station Findings for Conditions Inspection Report

Kitsap County

Parametrix, Inc. (PMX) completed a visual facility inspection of the Olympic View Transfer Station (OVTS) on August 16, 2016, as part of the Kitsap County Solid Waste Division (County) biennial facility inspection program. The facility inspection of the OVTS, operated by Waste Management, Inc. (WM), included the site, facilities, buildings, infrastructure, and fixed and mobile County-owned equipment. This inspection report reflects the condition of the facility at the time of the inspection.

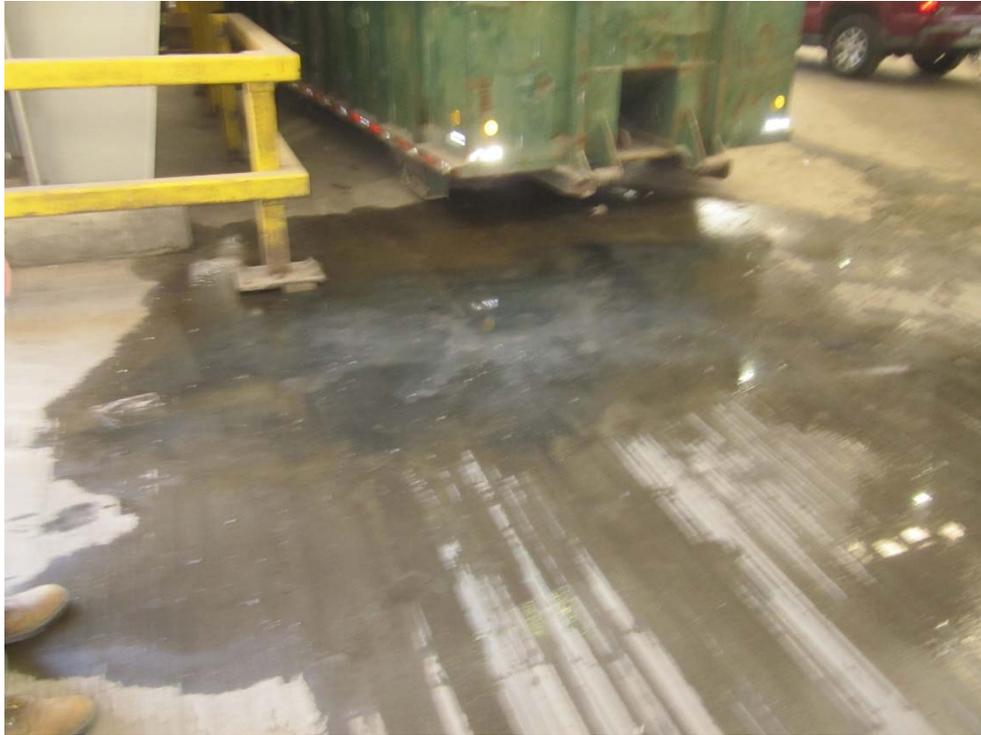
Building Substructure	Inspector	Overall Condition		
		Good	Fair	Poor
Foundation Walls	KH, IS	✓		
Commercial Tipping Floor - Ponding at commercial entrance; see Photo 1	KH, IS	✓		
Self-Haul Tipping Floor	KH, IS	✓		
Building Superstructure	Inspector	Overall Condition		
Primary Structural Steel Frame	KH, IS	✓		
Primary Structural Steel Columns	KH, IS	✓		
Secondary Wall Framing - Rust visible throughout area	KH, IS	✓		
Secondary Roof Framing - Rust visible throughout area	KH, IS	✓		
Concrete Stem Walls	KH, IS	✓		
Concrete Push Walls	KH, IS	✓		
Metal Wall Panels/Trim - Cleaning needed inside in the vicinity of chutes; see Photo 2 - Wall panel damaged above compactor chute and at north wall	KH, IS	✓

Photo 1: Water Ponds within Commercial Entrance

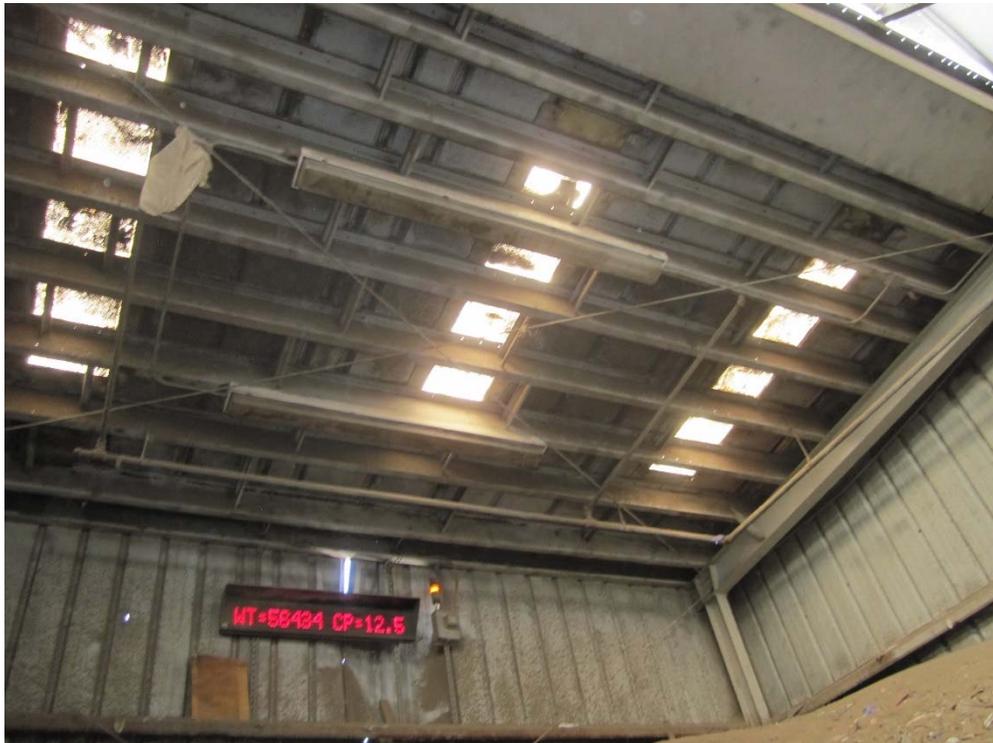
Photo 2: Chute Walls and Ceiling

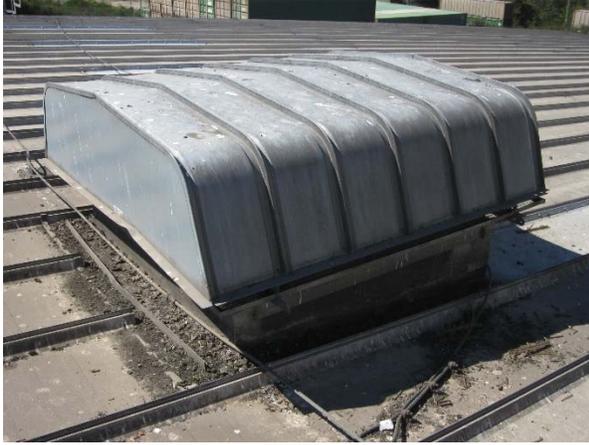
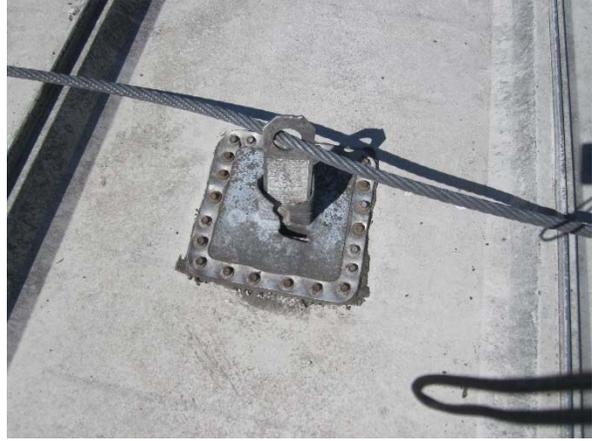
Translucent Wall Panels/Trim - Cleaning needed inside in the vicinity of chutes	KH, IS	✓		
Metal Roof Panels/Trim - Cleaning needed outside in the vicinity of vents and ridgeline; see Photo 3 - Cleaning needed inside in the vicinity chutes - Exterior fall restraint system boots have failed; see Photo 4	KH, IS	✓		
Translucent Roof Panels/Trim	KH, IS	✓		
Louvers and Vents - Roof ridge cap vent screens need to be cleaned	KH, IS	✓		
Coiling Overhead Doors/Door Operators and Hardware - Safety device wiring damaged - Cleaning needed	KH, IS	✓		
Personnel Doors/Door Hardware	KH, IS	✓		
Roof Insulation - Insulation in the process of being replaced with rigid insulation; see Photo 5 - Some insulation not mounted correctly. Installation requirements should be confirmed (bands, edge tape, joints); see Photo 6	KH, IS		✓	
Gutters and Downspouts - West downspouts recently replaced and hard piped to stormwater system	KH, IS	✓

Photos 3 and 4: Roof and Fall Restraint System

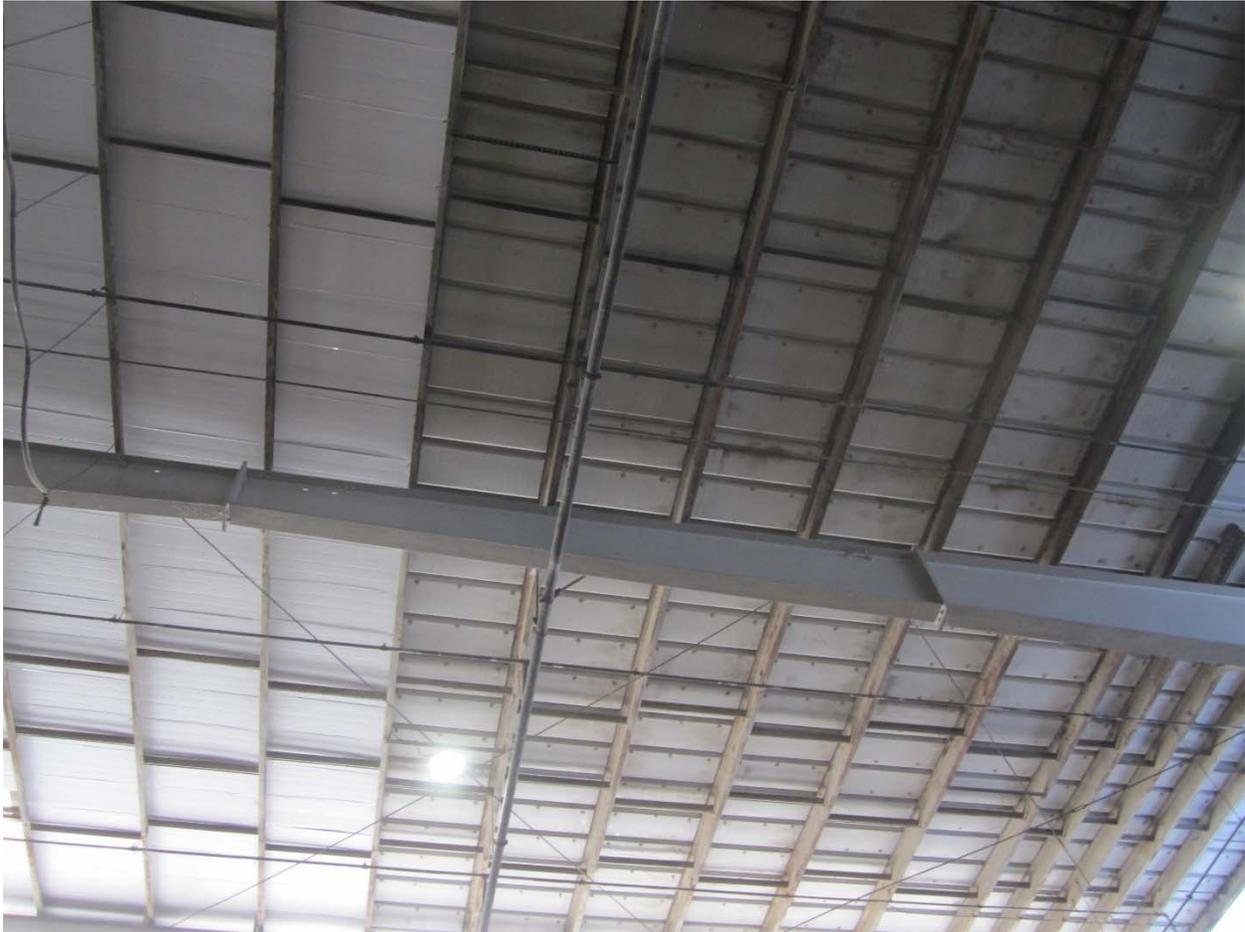
Photo 5: Insulation Replacement

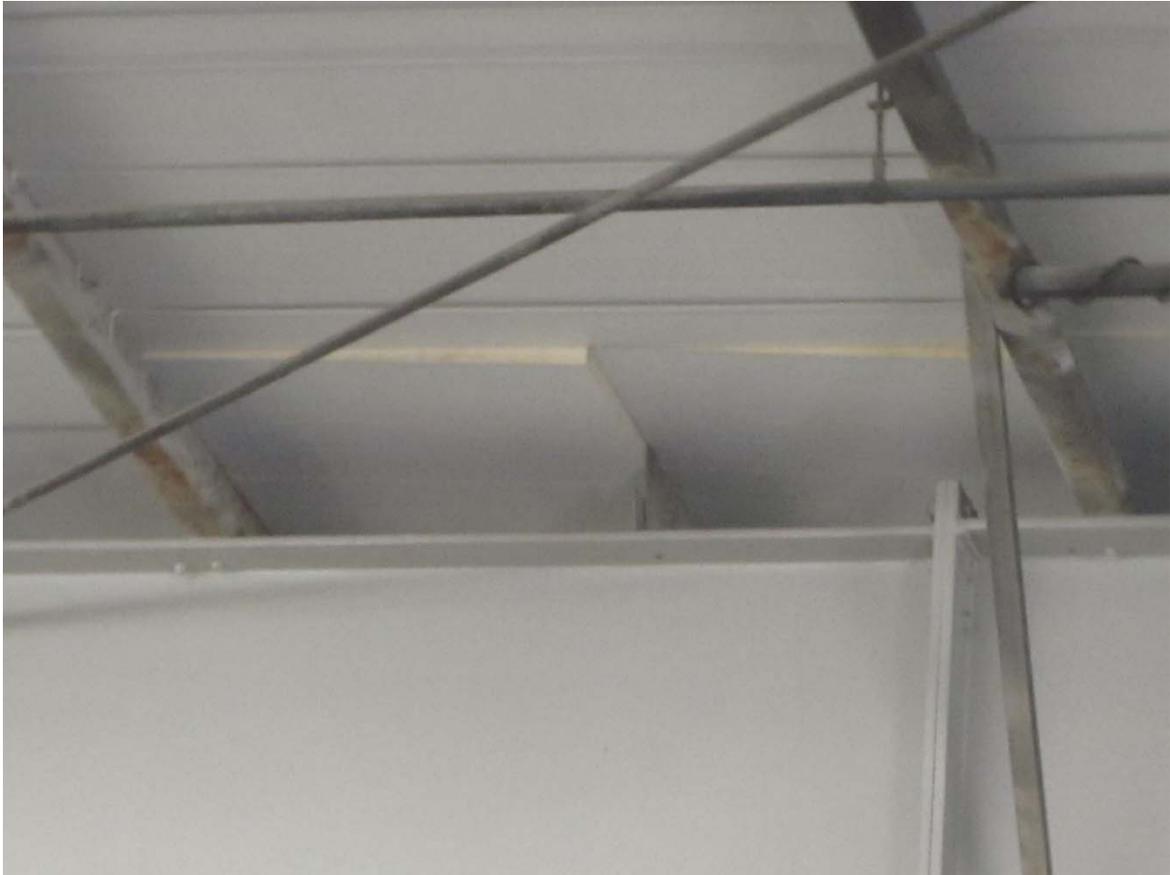
2. The installation of new ceiling insulation should be reviewed for conformance with the manufacturer's recommendations. Though not complete at the time of review, there is question as to the mounting method being used and the need to seal panel joints. The installation support bands being used did not reflect the manufacturer's installation methods represented in online available information. Additionally, it is recommended that the insulation be pressure wash tested shortly after installation is complete, or at least within the warranty period, to confirm that the installation method is sufficient to withstand the procedure.

Photo 6: Insulation Installation Method

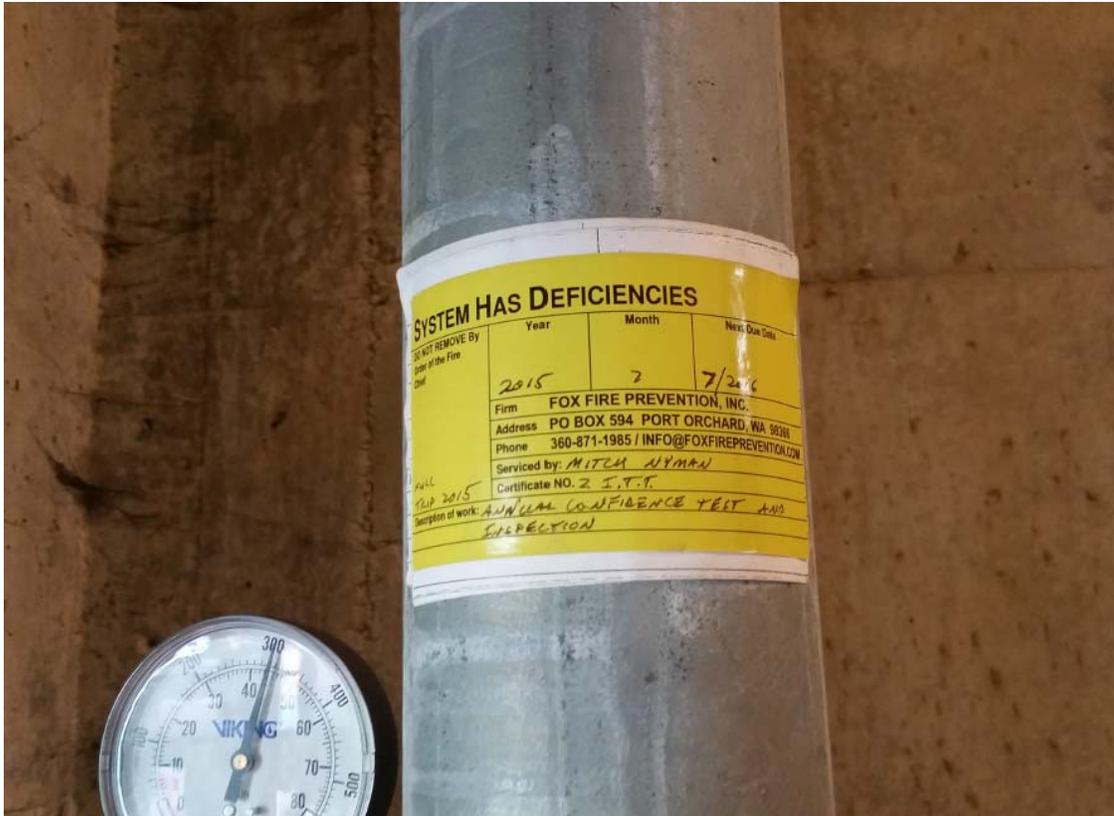
Photo 9: Fire Sprinkler System Riser

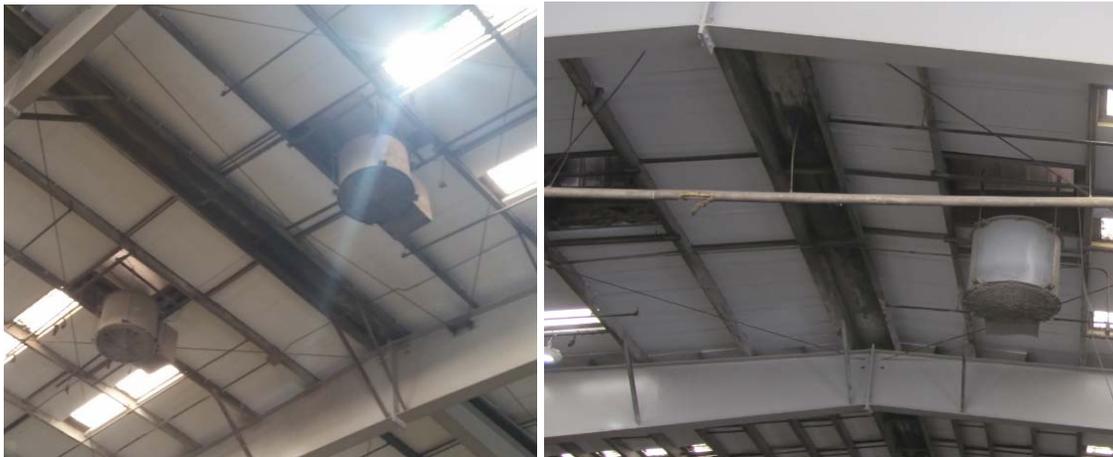
3. The exhaust provisions from the Transfer Building are not functioning properly and are creating a health risk for occupants. Six of the original 10 high-capacity fans have been replaced with in-line vertical fans whose discharge is not connected to the roof openings, resulting in the fans recirculating most of the air in the building rather than exhausting it. The other four original fans have been removed, but have not been replaced. All required fans should be installed with proper ducting to ensure adequate exhausting is being provided for dust and the operation of motorized vehicles.

Photos 10 and 11: Missing Fans and Exhaust Ductwork

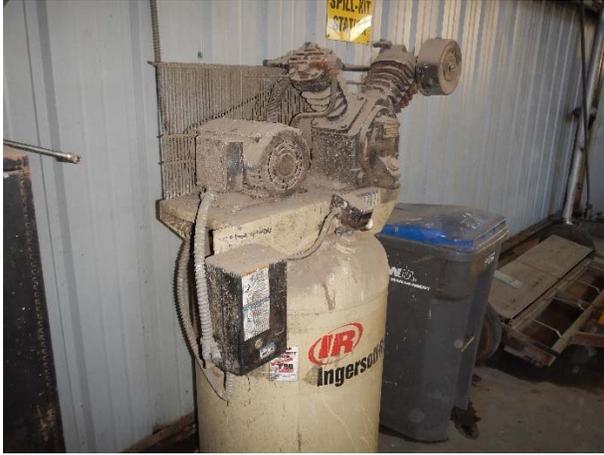
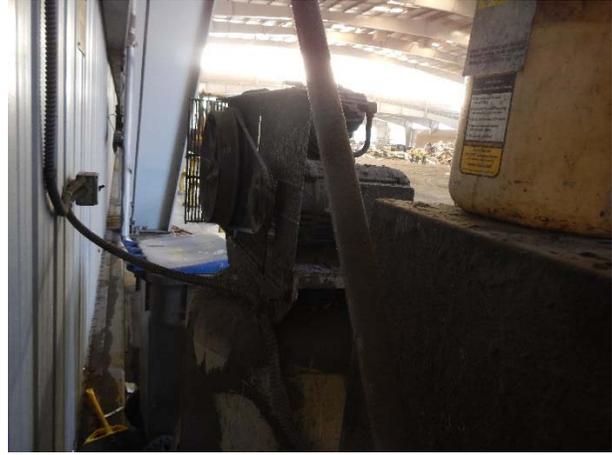
Photos 12 and 13: Air Compressor Dust and Missing Guard

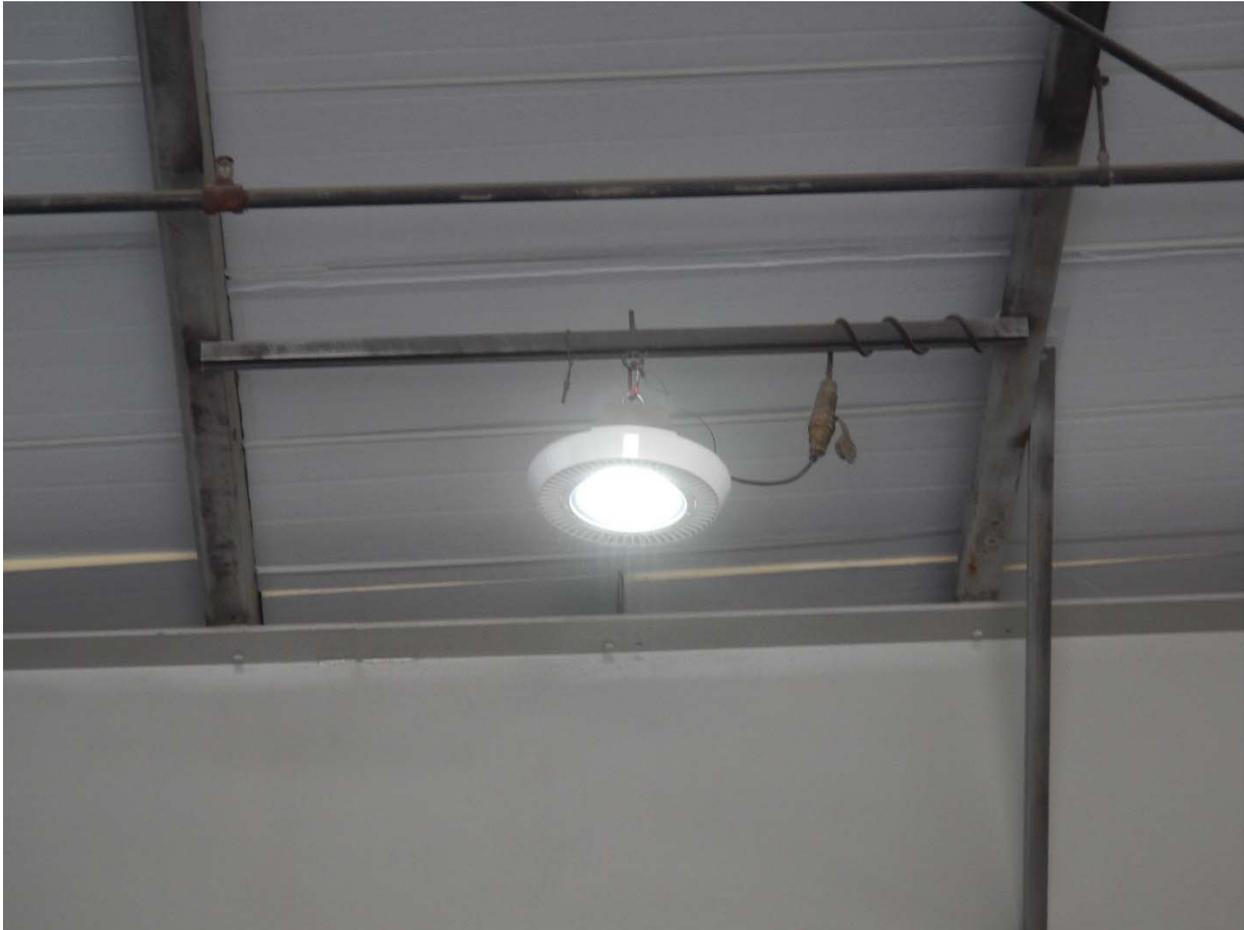
Photo 14: Interior Light Fixture Mounting

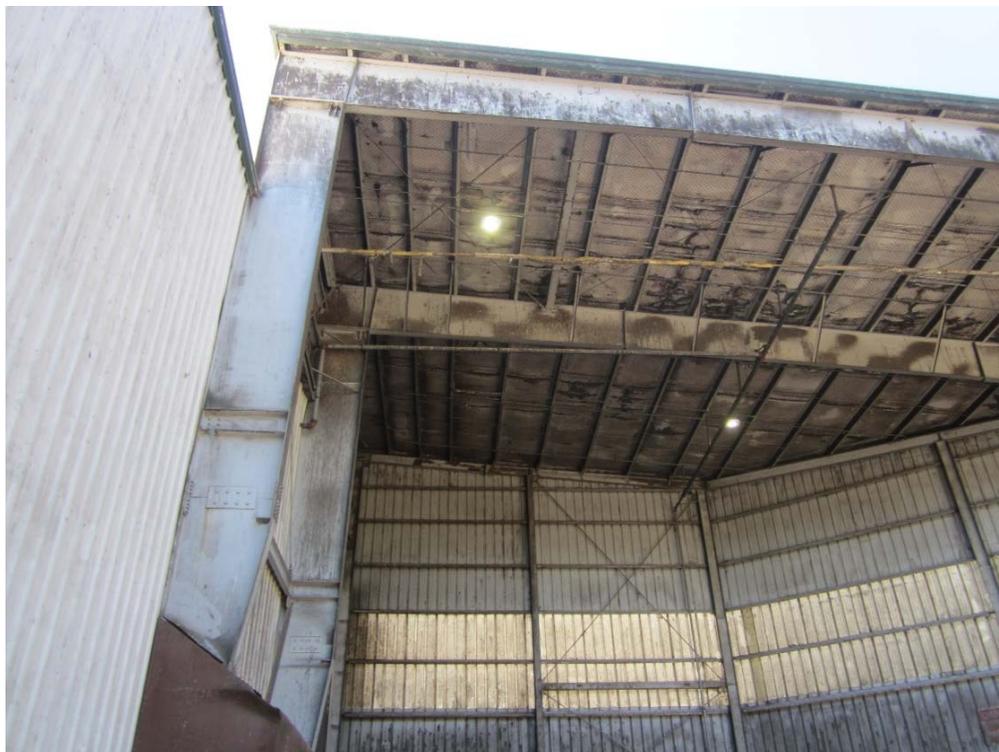
Photo 1: Secondary Wall and Roof Framing Rust

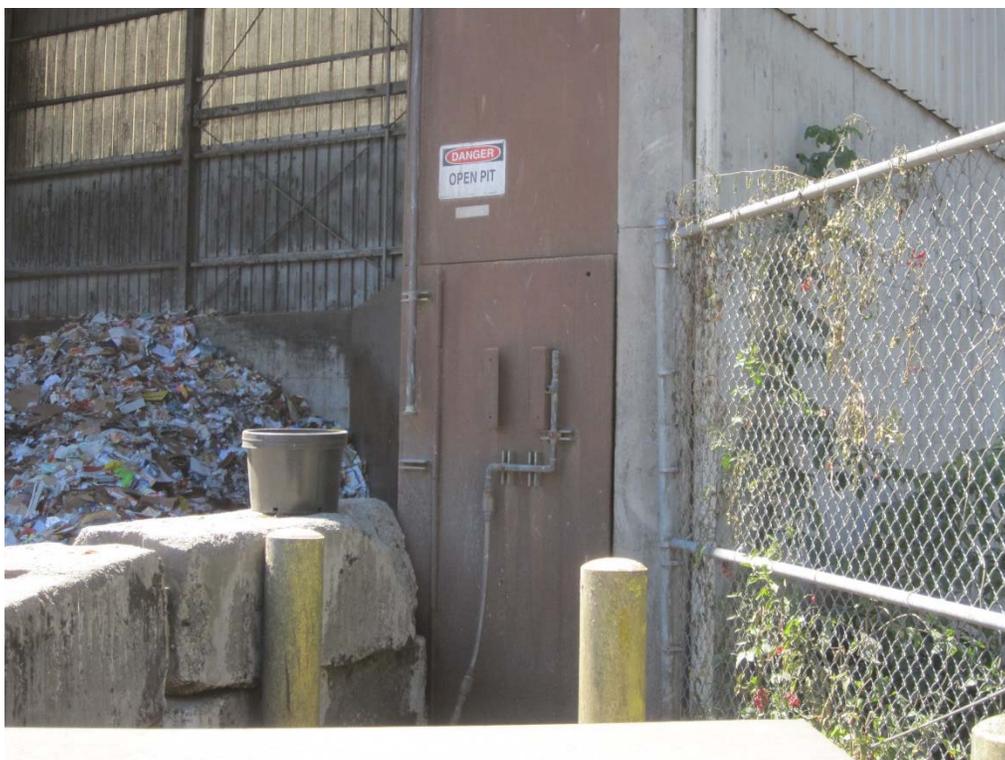
Photo 2: North Hose Reel

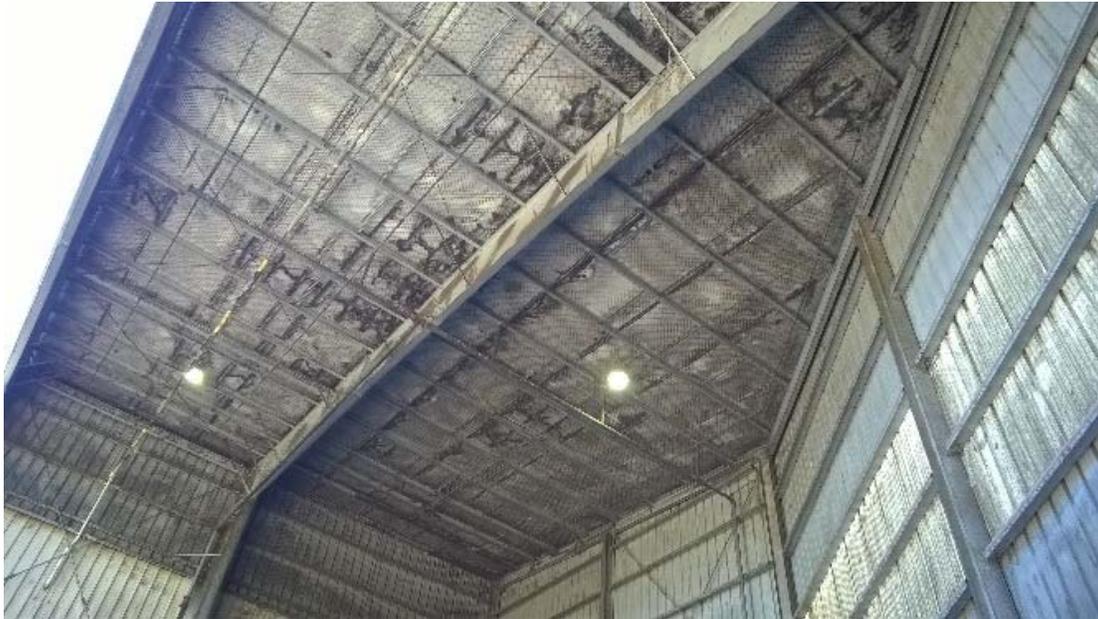
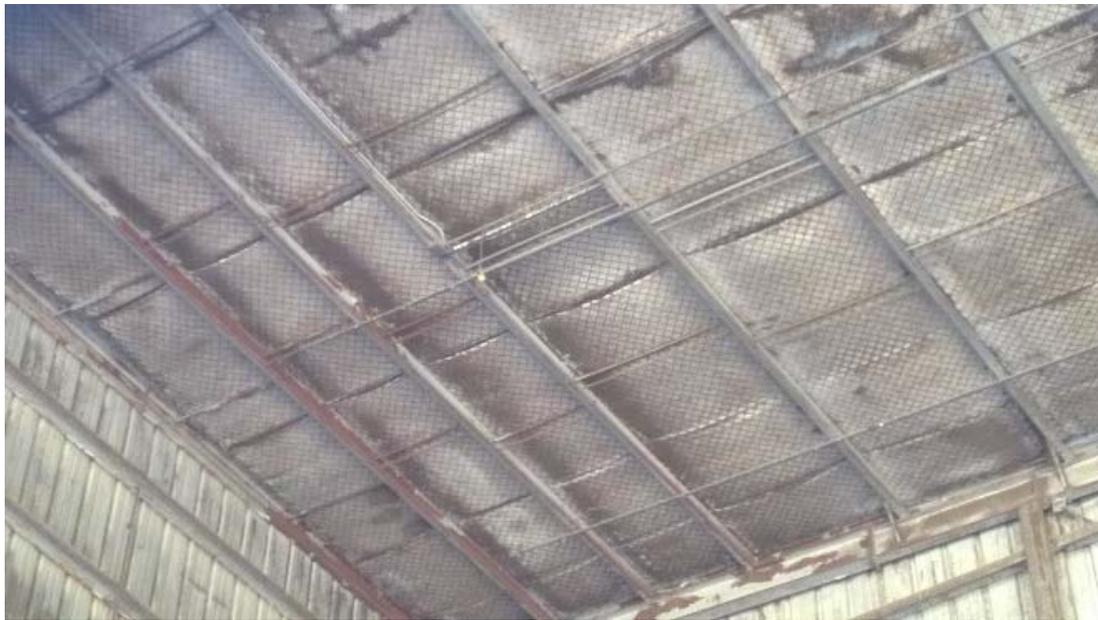
Lighting Fixtures	JR		✓	
<ul style="list-style-type: none"> Interior Fixtures - New LED fixtures - Previously, there were 5 ceiling fixtures. Currently, there are only 3, but it appears the area is wired for a fourth in the southwest corner; see Photos 3 and 4. 	JR, IS		✓

Photos 3 and 4: Missing Light Fixture

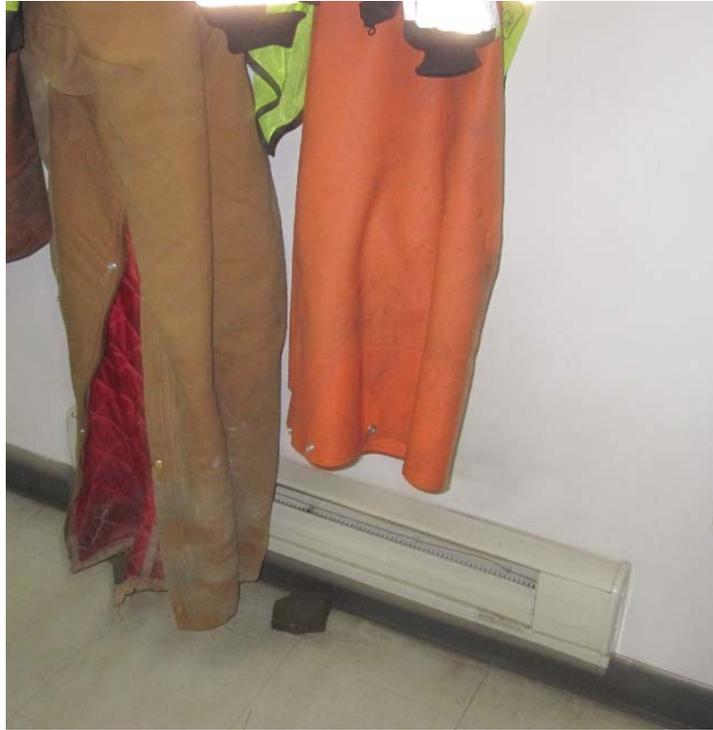
Photo 1: Baseboard Heater Fire Hazard

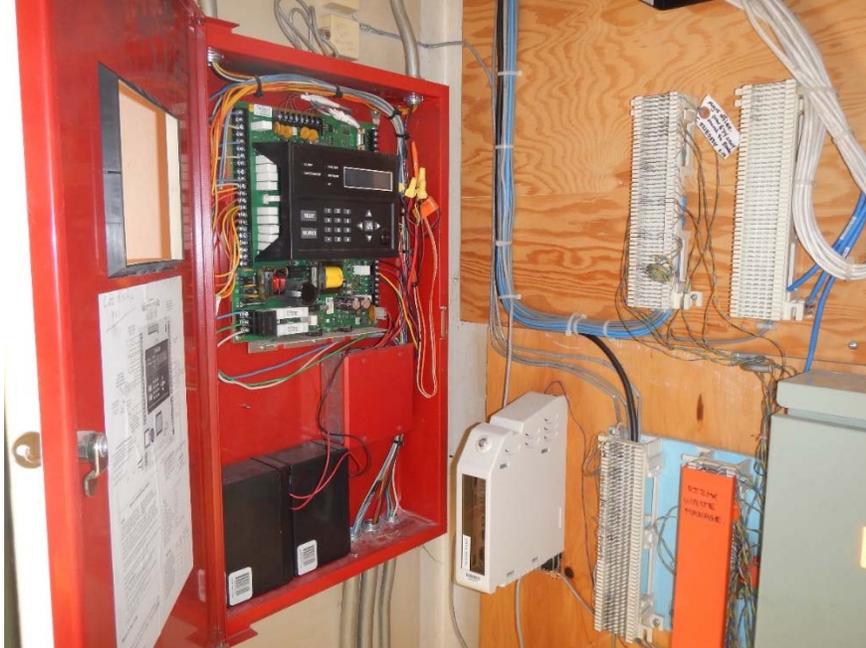
Photo 2: Fire Alarm Panel Obstruction

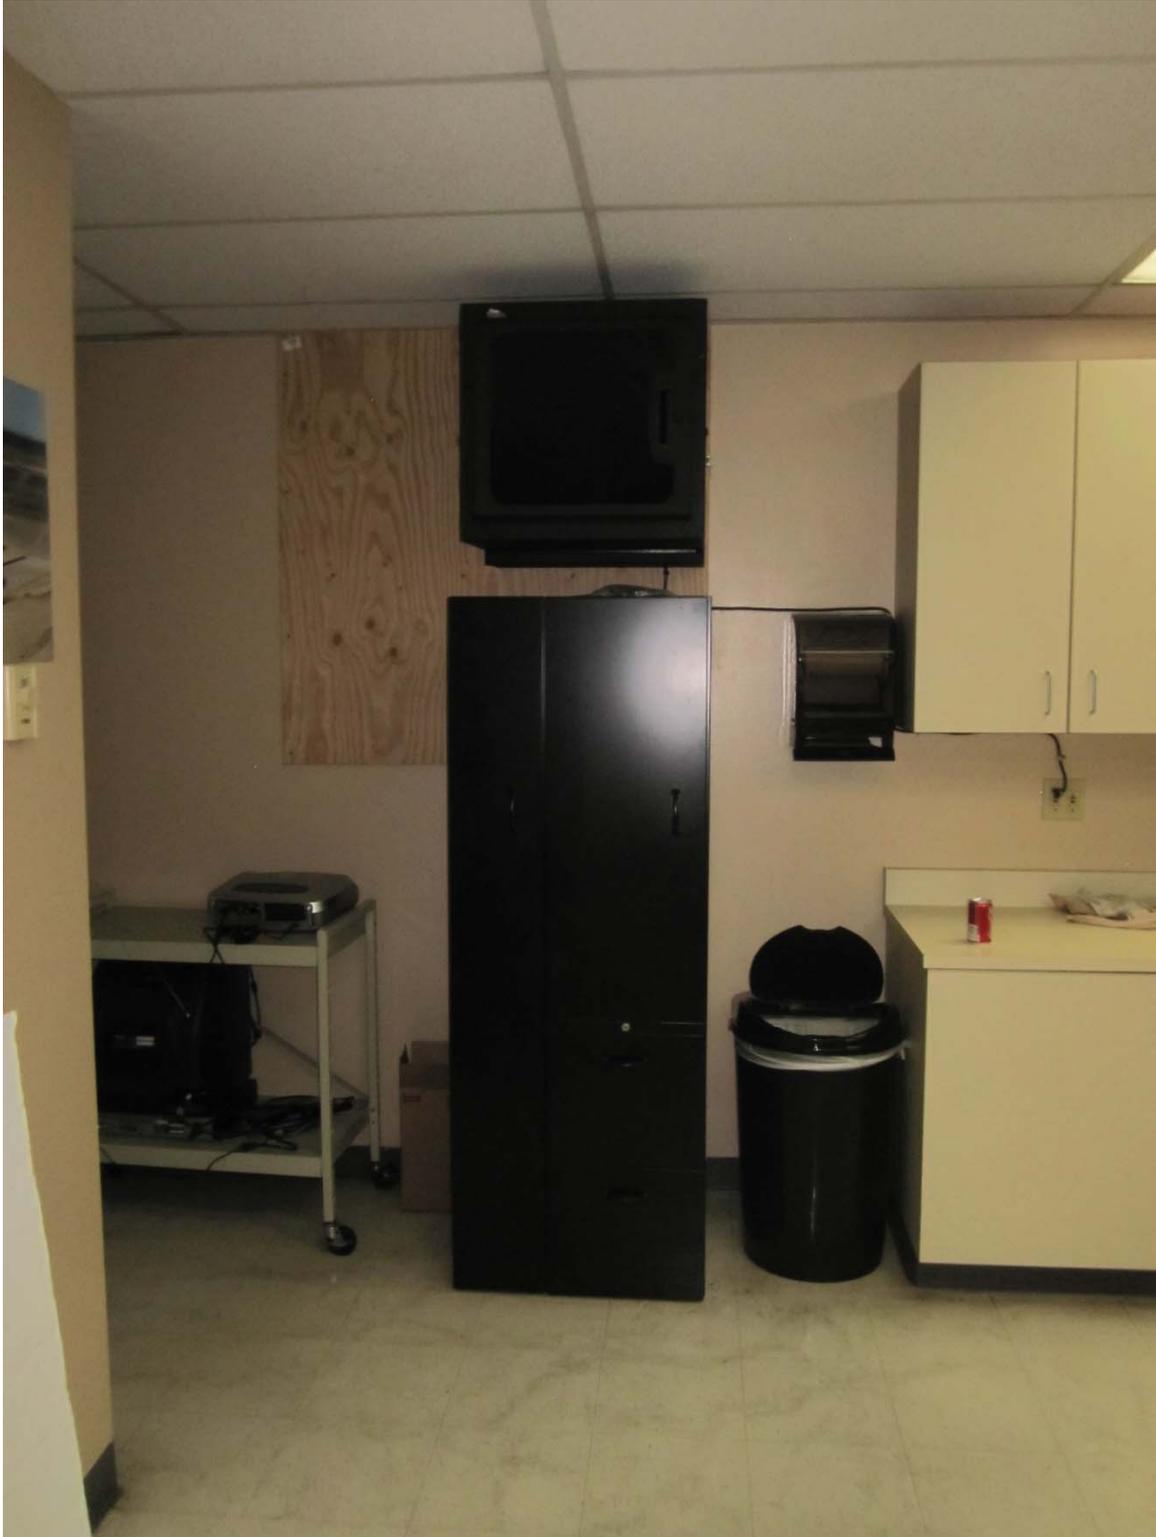
2. The server cabinet has been relocated to the County office space to the left of the sink. The change was made to improve the heat balance for the equipment; however, the power for the cabinet is from a general-use ground fault circuit interrupter (GFCI) receptacle at the sink counter. There is an uninterruptible power supply (UPS) inside the cabinet to protect against a brief power loss, but there is risk of the GFCI tripping and personnel not resetting the outlet. This would result in power loss to the server. It is recommended that a dedicated receptacle be installed to serve the cabinet.

Photo 3: Server Cabinet

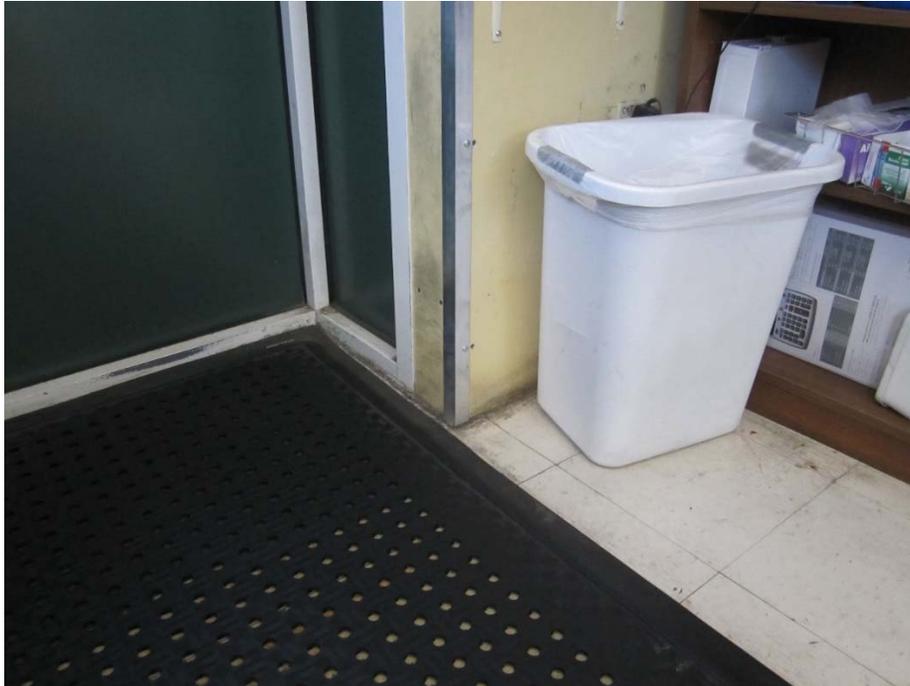
Photo 1: Repaired Attendant Walls

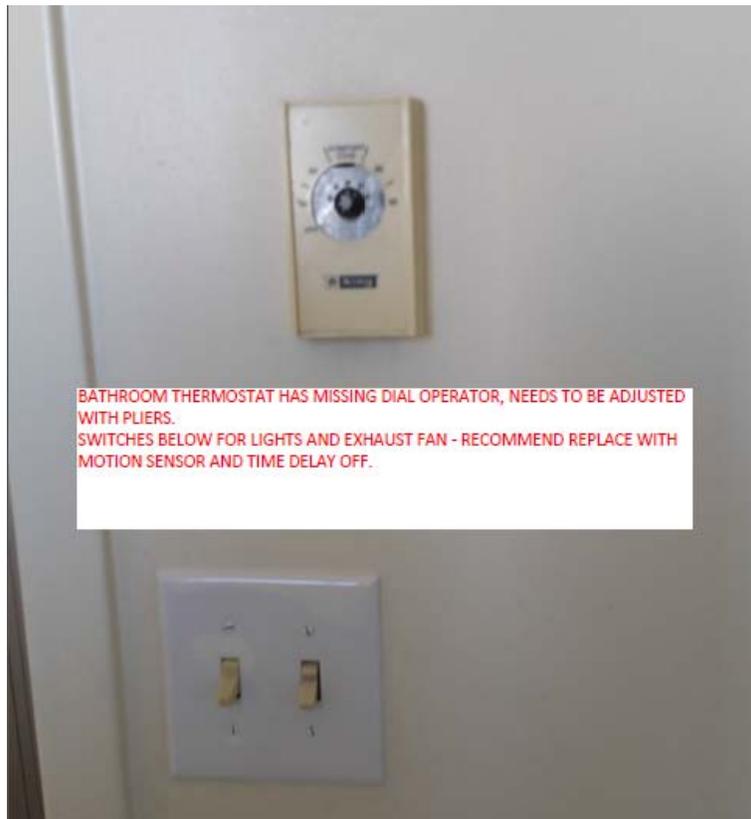
Photo 2: Bathroom Controls

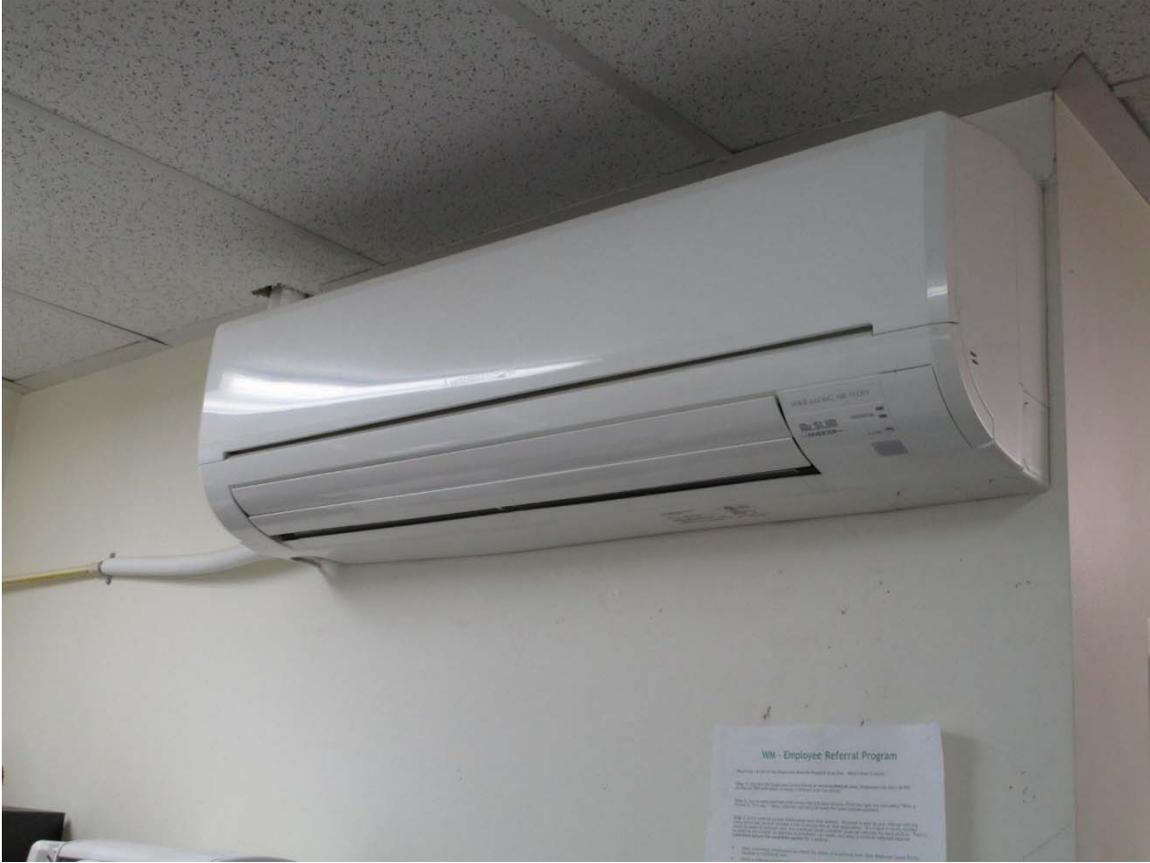
Photo 3: Split System Heat Pump

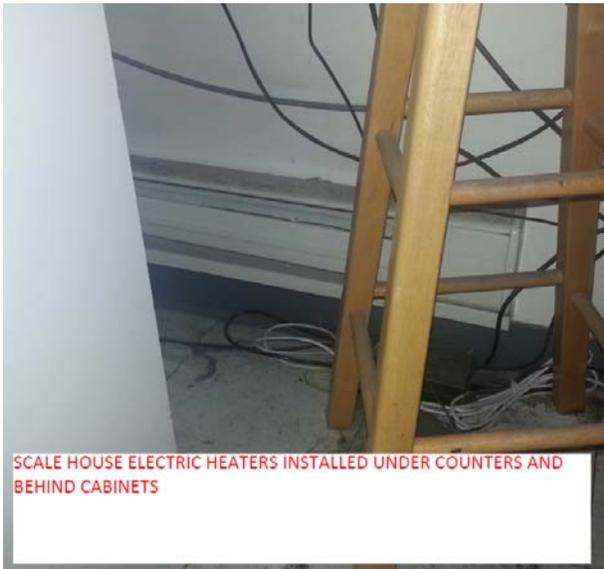
4. The HVAC within the scale house is a concern. The electric baseboard heaters in the scale house are covered by cabinets and desks which creates a fire hazard. Electrical cords are also in close proximity to the electric baseboard heaters. Regarding ventilation, the 2015 International Mechanical Code (IMC) does permit the use of natural ventilation through windows, doors, louvers or other openings with a minimum operable opening of 4% of the floor area being ventilated. With the size of the scale house and the existing operable window and doors, natural ventilation will classify the spaces to be in compliance; however, the scale house openings are considered a noxious contamination source in accordance with IMC Chapter 4, Article 401.4 – Intake Opening Location. Alternative ventilation should be provided. See Appendix B for code requirements.

SCALE HOUSE ELECTRIC HEATERS INSTALLED UNDER COUNTERS AND BEHIND CABINETS

Photos 4 and 5: Baseboard Heaters

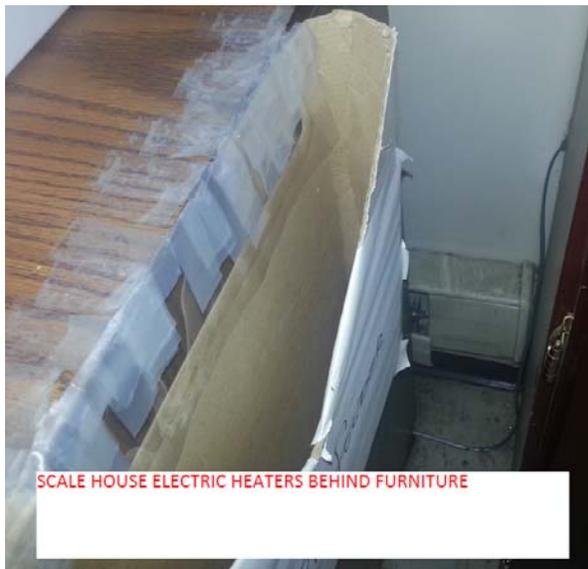
SCALE HOUSE ELECTRIC HEATERS BEHIND FURNITURE

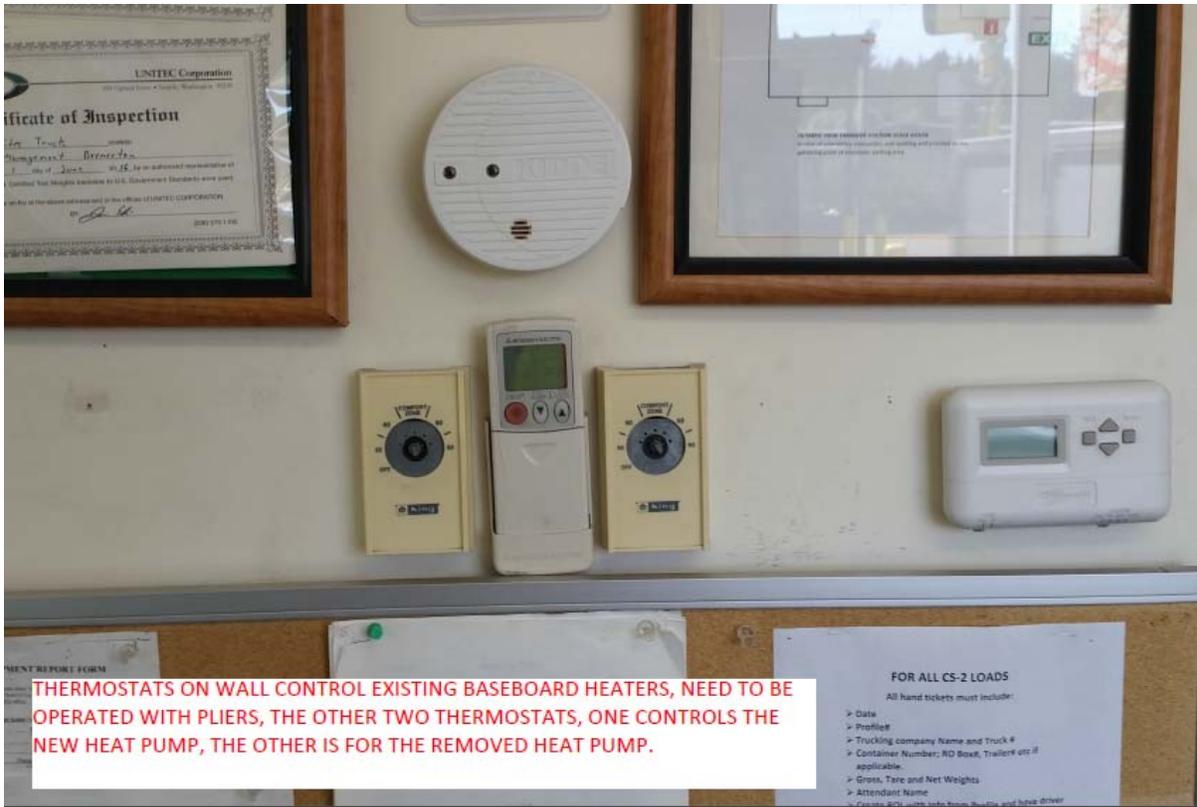
Photo 6: Electric Heater Controls

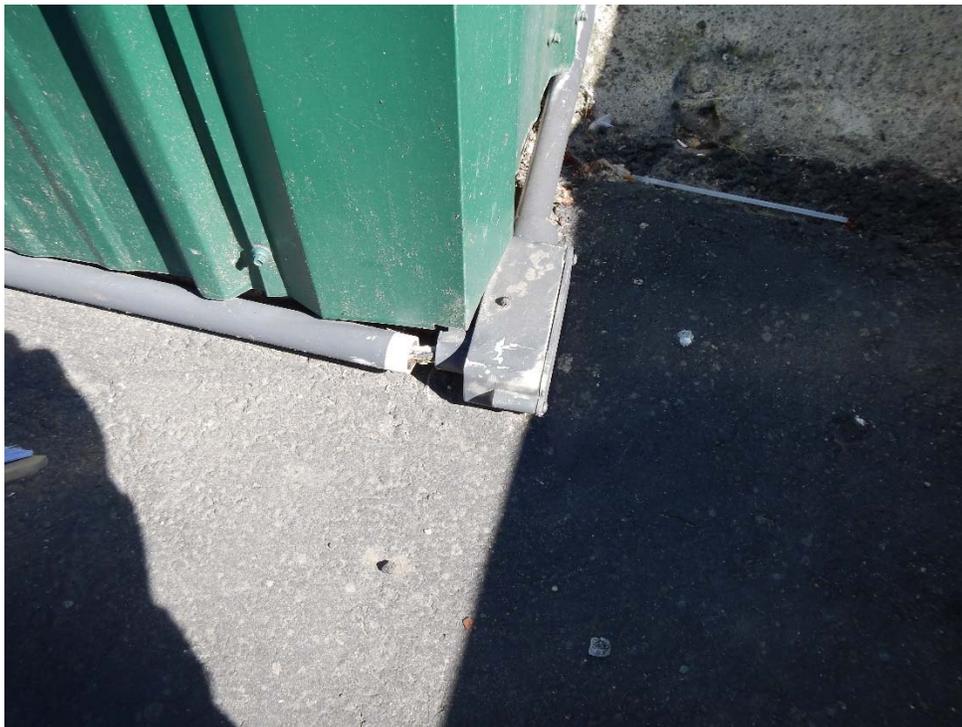
5. Deteriorating exterior conduits are a concern. Some conduits have been pulled out of associated connectors. Other conduits have been broken. Both conditions have resulted in exposed cables. There are also seal-tight flexible conduits that have extensive sun damage which should be replaced before failure. Conduit mounting methods, connectors, transitions, and repairs should be installed in accordance with the National Electrical Code (NEC).

Photo 7: Conduit Separation

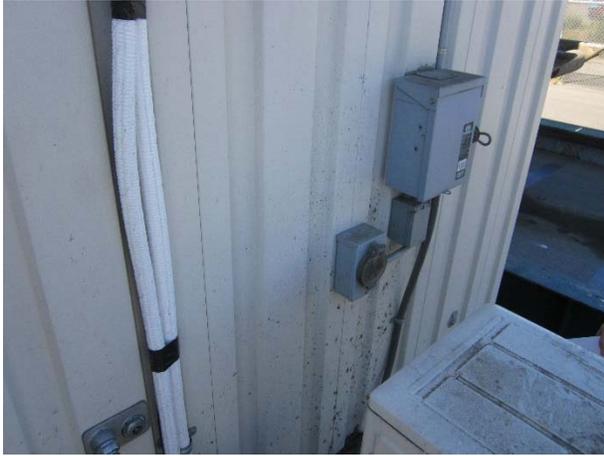
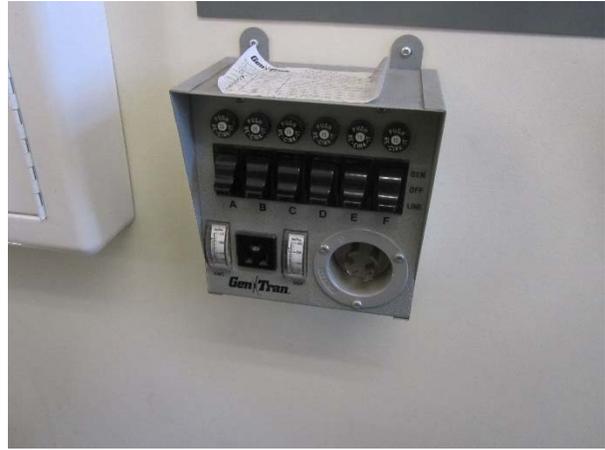
were intended for connecting the portable generator and, unless this receptacle was internally disconnected within the panel wiring, it would be energized and exposed when the facility is powered from the generator. This would be a very hazardous condition and should be investigated and corrected as required. At a minimum, it is recommended to plug and seal, or remove, the exposed receptacle, even if it is not wired. Also, the Underwriters Laboratories (UL) listing of this panel may be voided as a result of the wiring modification that has been made to it.

Photos 8 and 9: GenTran Receptacles

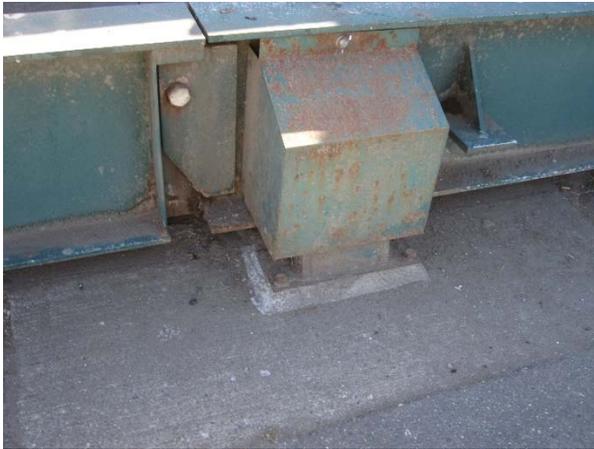
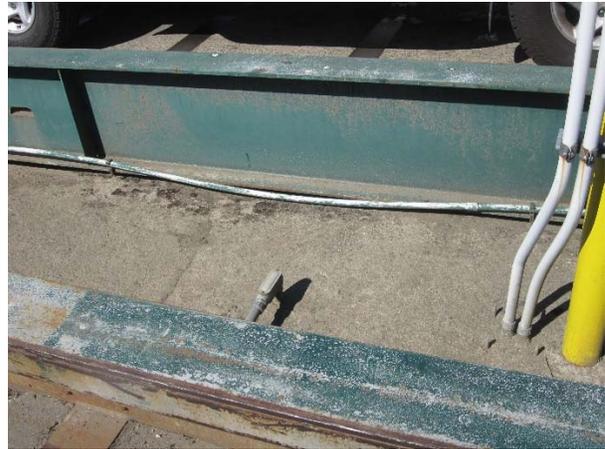
Photos 10 and 11: Scale Coatings

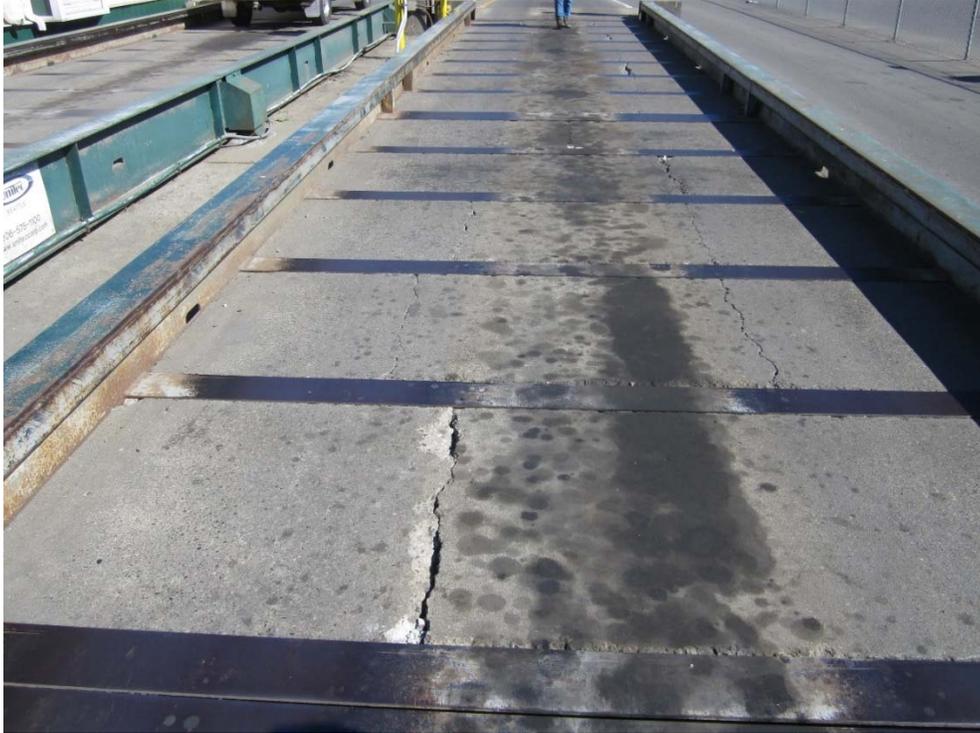
6. The long-term wear on the scales is a concern. A meeting should be scheduled with a knowledgeable mechanic from the scale manufacturer (Unitec) to review the condition of scales and identify any preventive maintenance needed for scales. The fractured inbound commercial concrete deck should be replaced.

Photo 12: Inbound Commercial Scale Deck

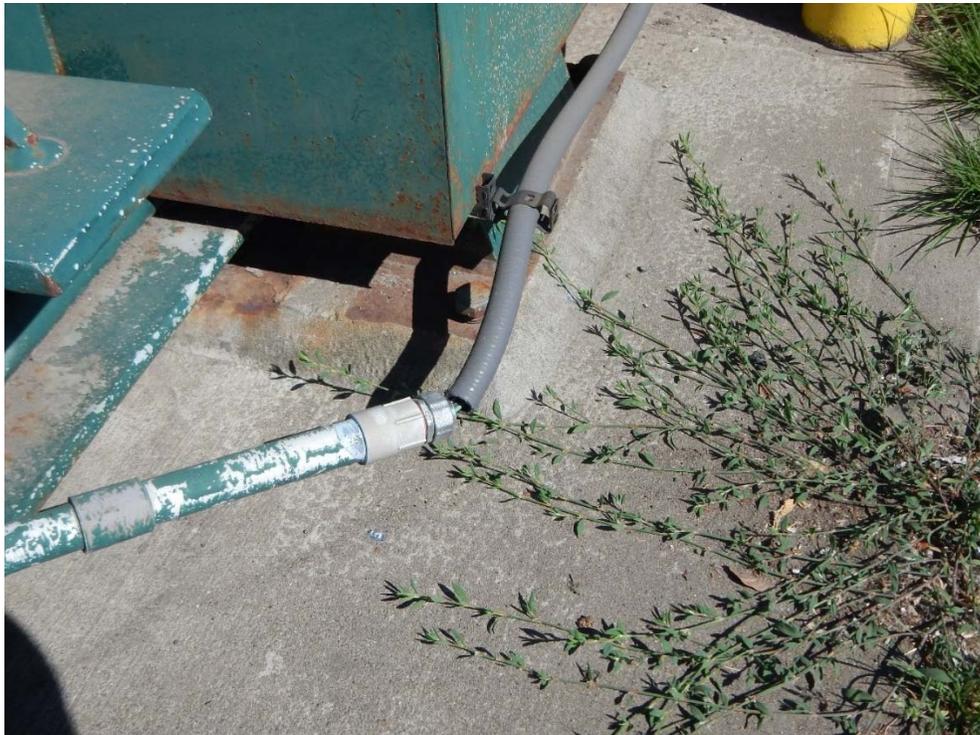
Photo 13: Flexible Conduit Pulled Out of Connectors

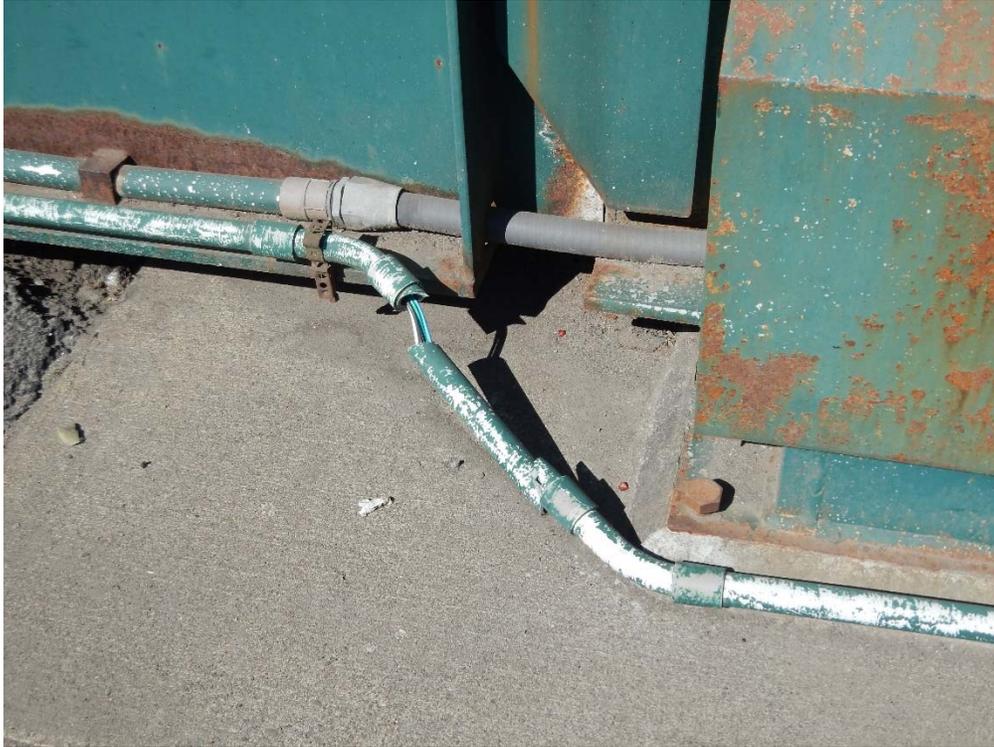
Photo 14: Broken Conduit
