Olympic View Transfer Station Findings for Conditions Inspection Report

Kitsap County

Parametrix, Inc. (PMX) completed a visual facility inspection of the Olympic View Transfer Station (OVTS) on August 16, 2016, as part of the Kitsap County Solid Waste Division (County) biennial facility inspection program. The facility inspection of the OVTS, operated by Waste Management, Inc. (WM), included the site, facilities, buildings, infrastructure, and fixed and mobile County-owned equipment. This inspection report reflects the condition of the facility at the time of the inspection.

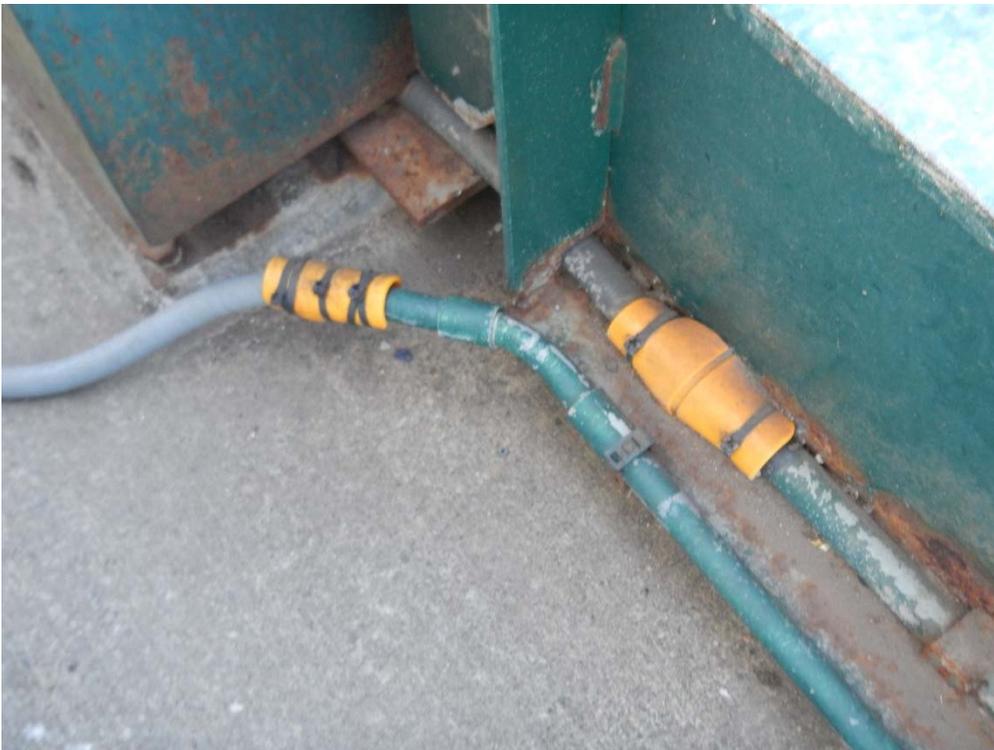
5. Deteriorating exterior conduits are a concern. Some conduits have been pulled out of associated connectors. Other conduits have been broken. Both conditions have resulted in exposed cables. There are also seal-tight flexible conduits that have extensive sun damage which should be replaced before failure. Conduit mounting methods, connectors, transitions, and repairs should be installed in accordance with the National Electrical Code (NEC).

Photo 15: Improper Conduit Repairs

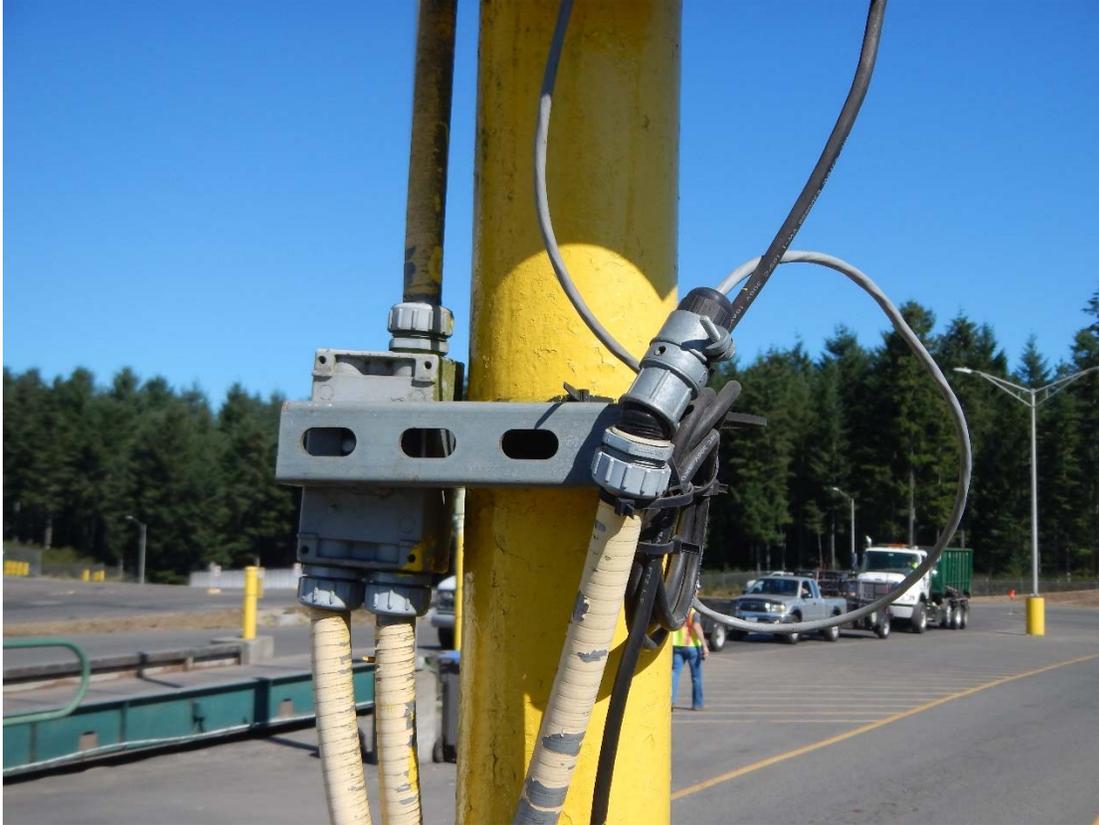
Photo 16: Improper Conduit Transition

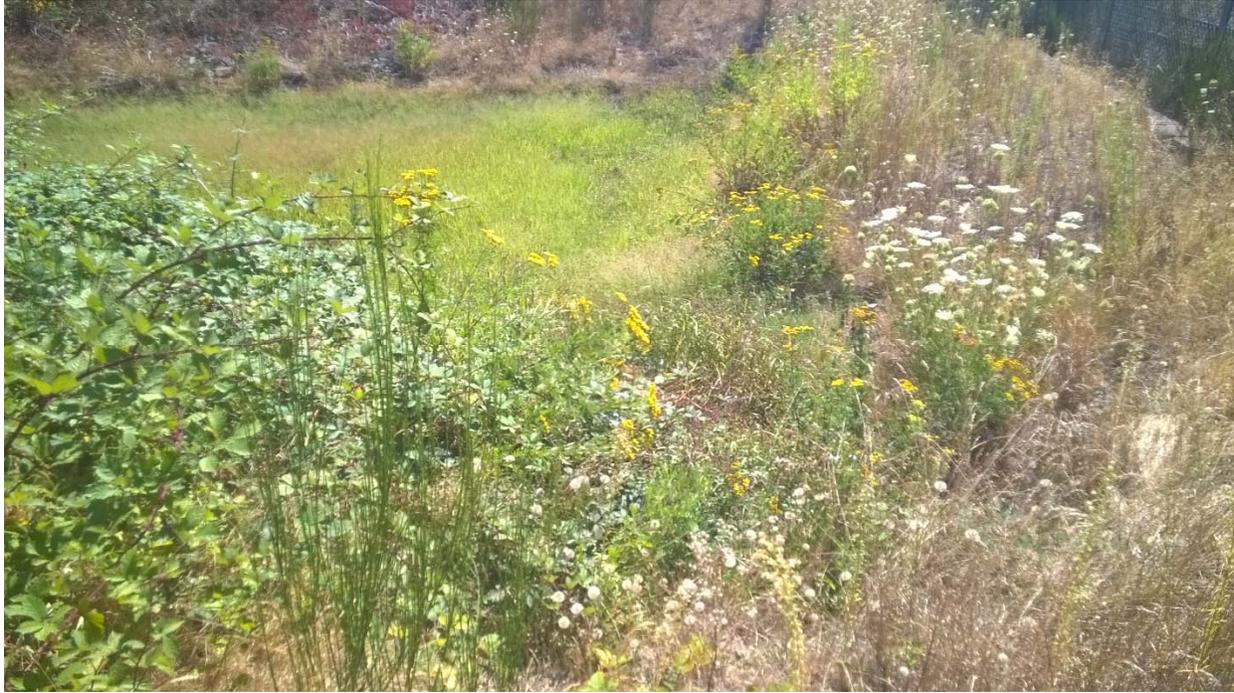
Photo 1: Pond A Vegetation

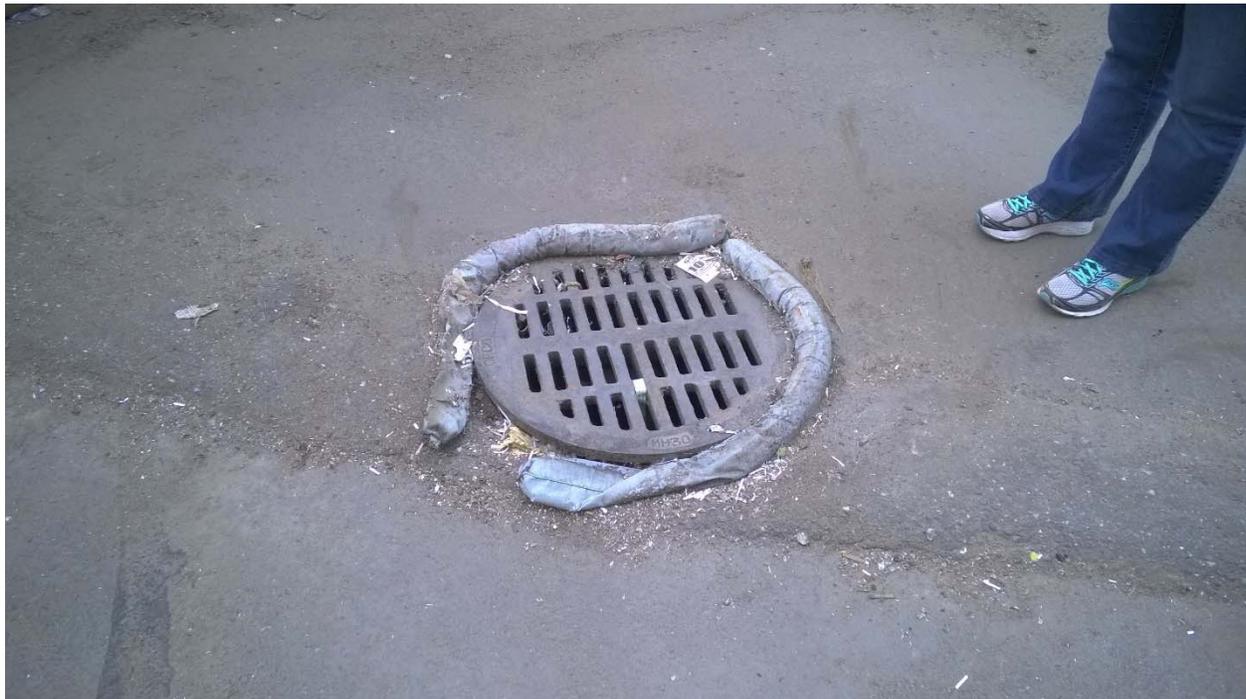
Photo 2: Incorrectly Sized Grate

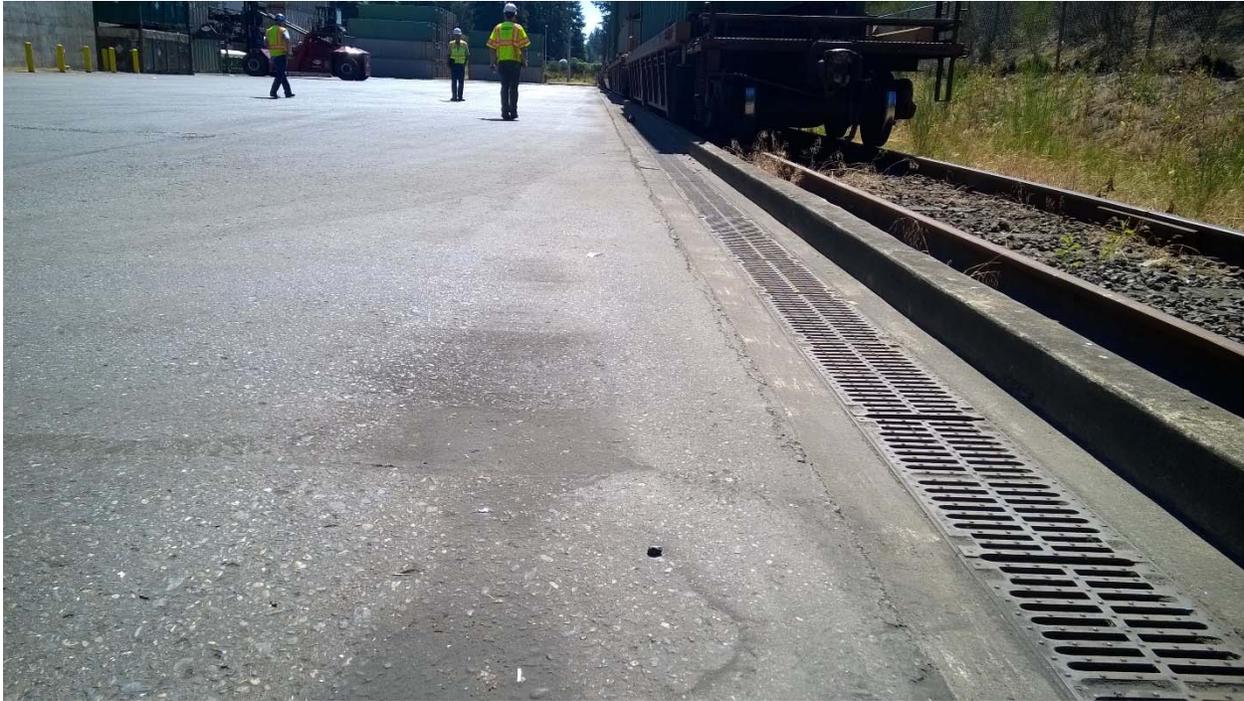
Photo 3: Depression at Rail Spur

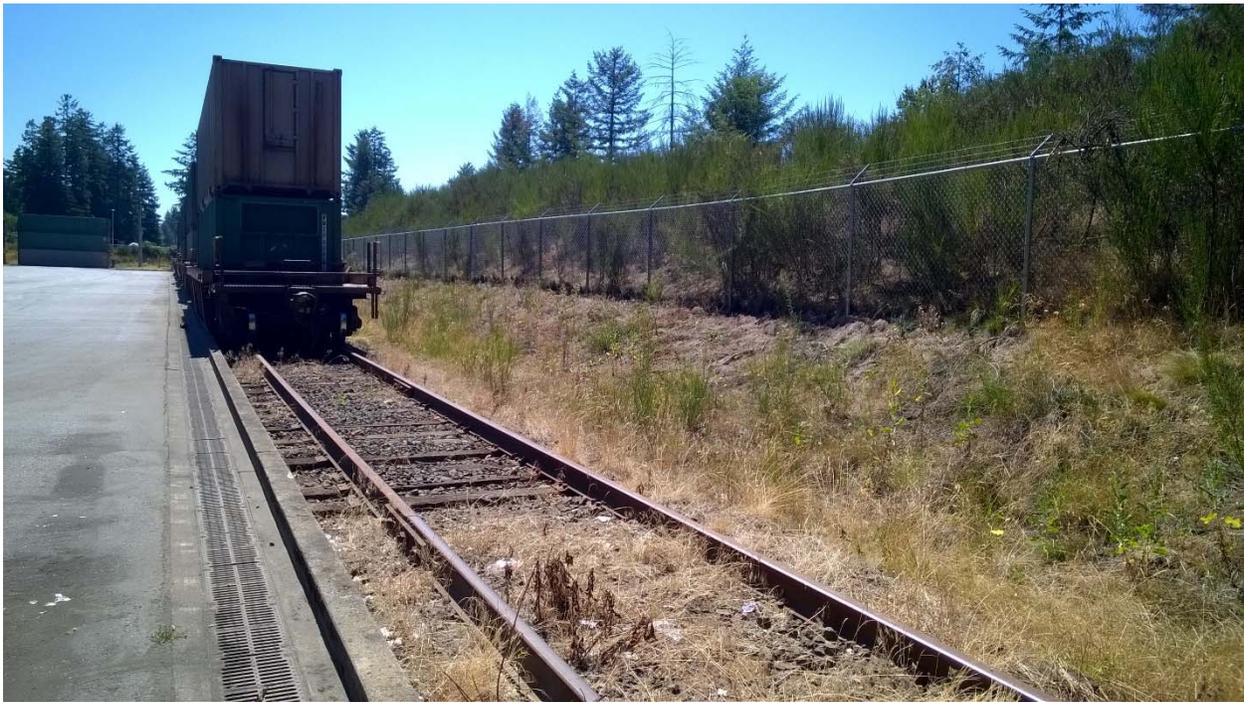
Photo 4: Invasive Vegetation

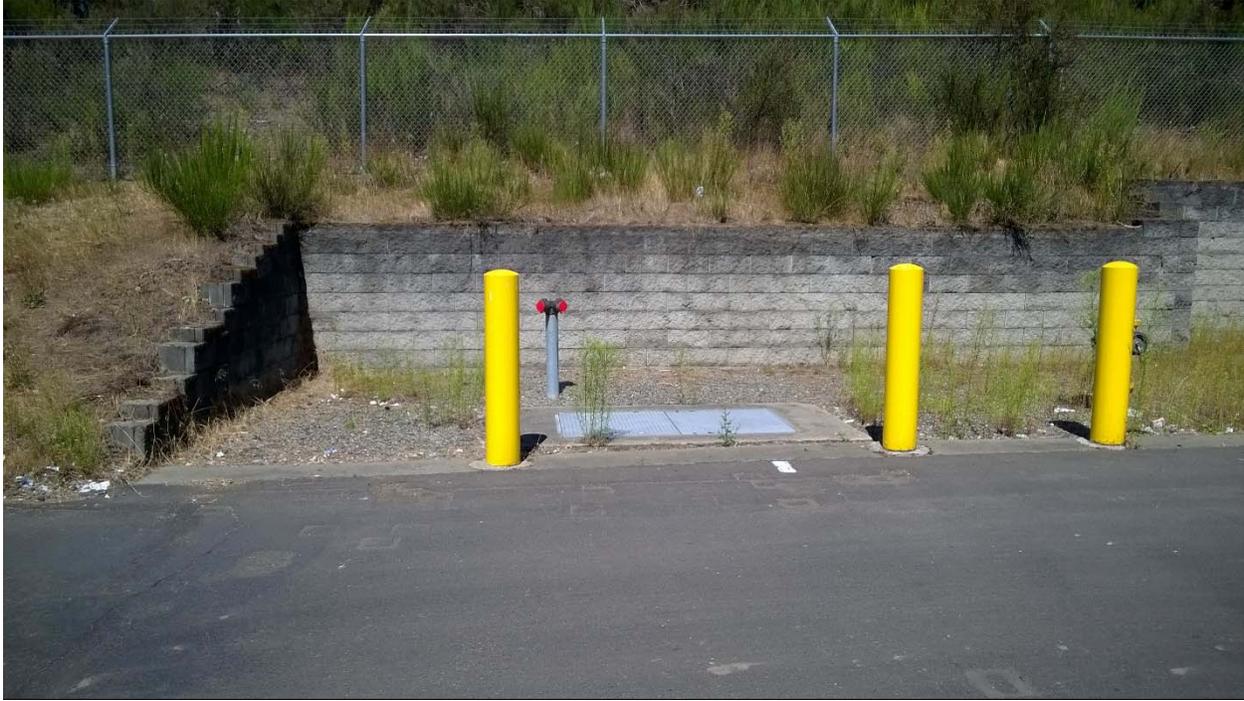
Photo 5: Invasive Vegetation

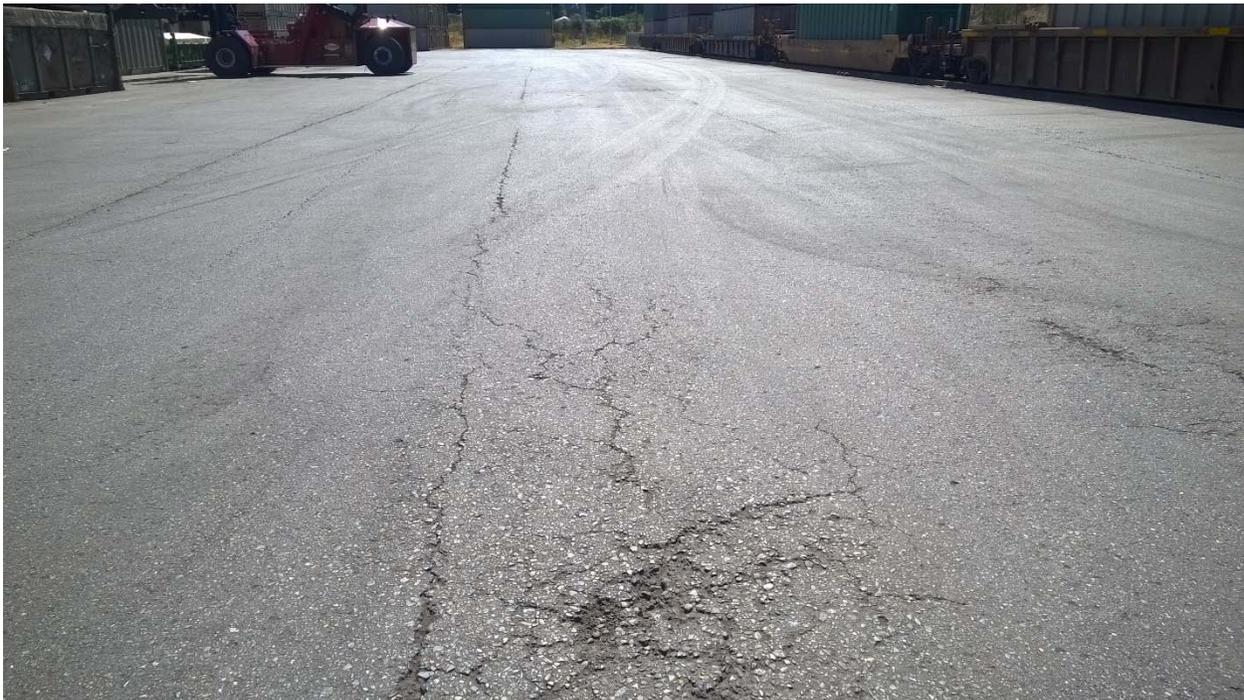
Photo 6: Pavement Conditions

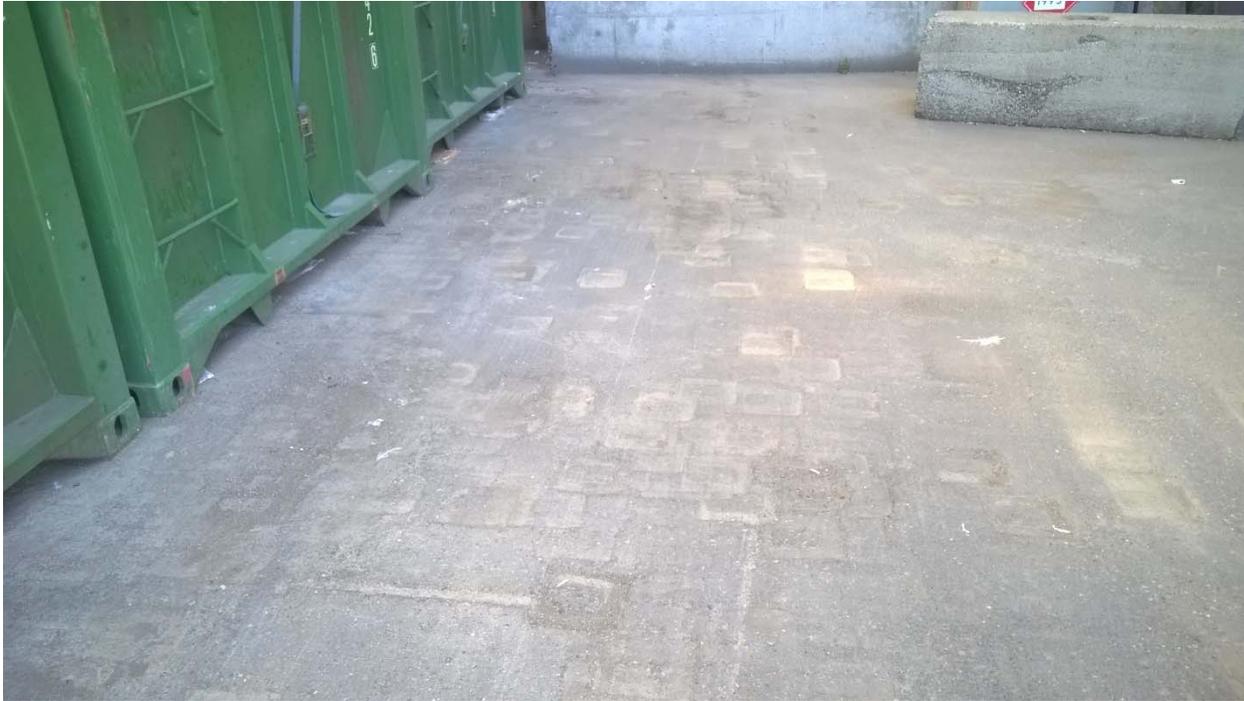
Photo 7: Pavement Conditions

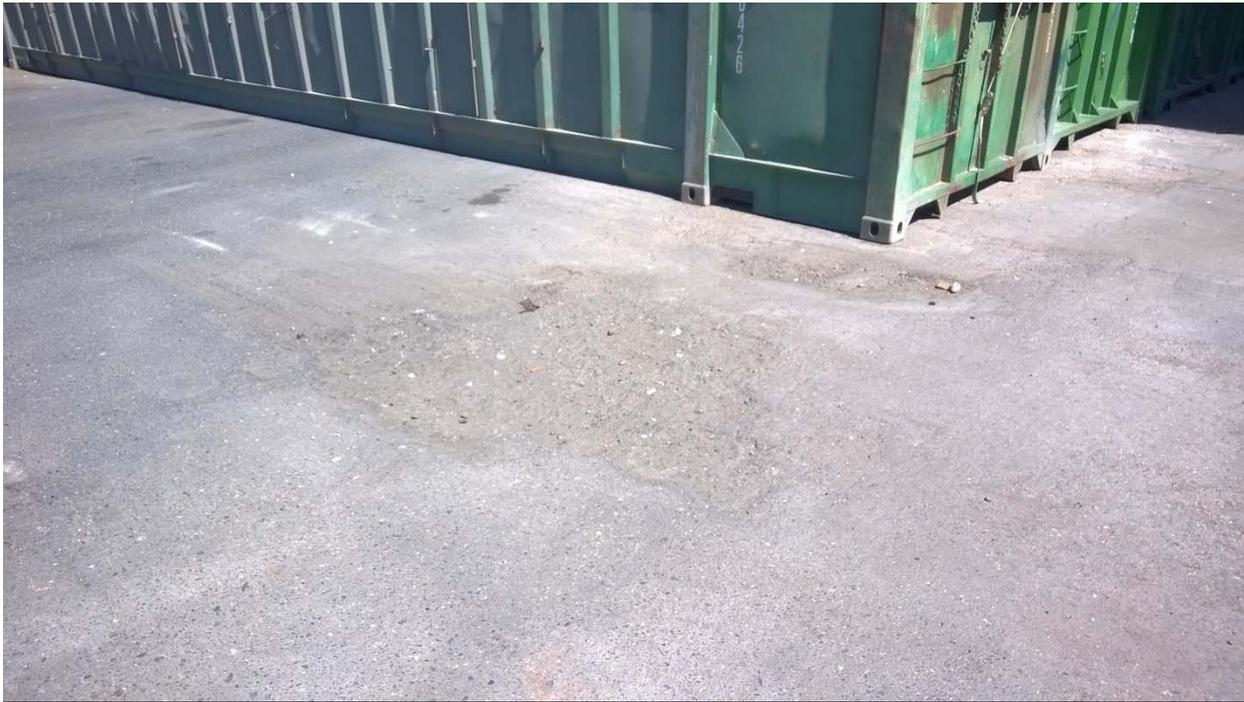
Photo 8: Pavement Conditions

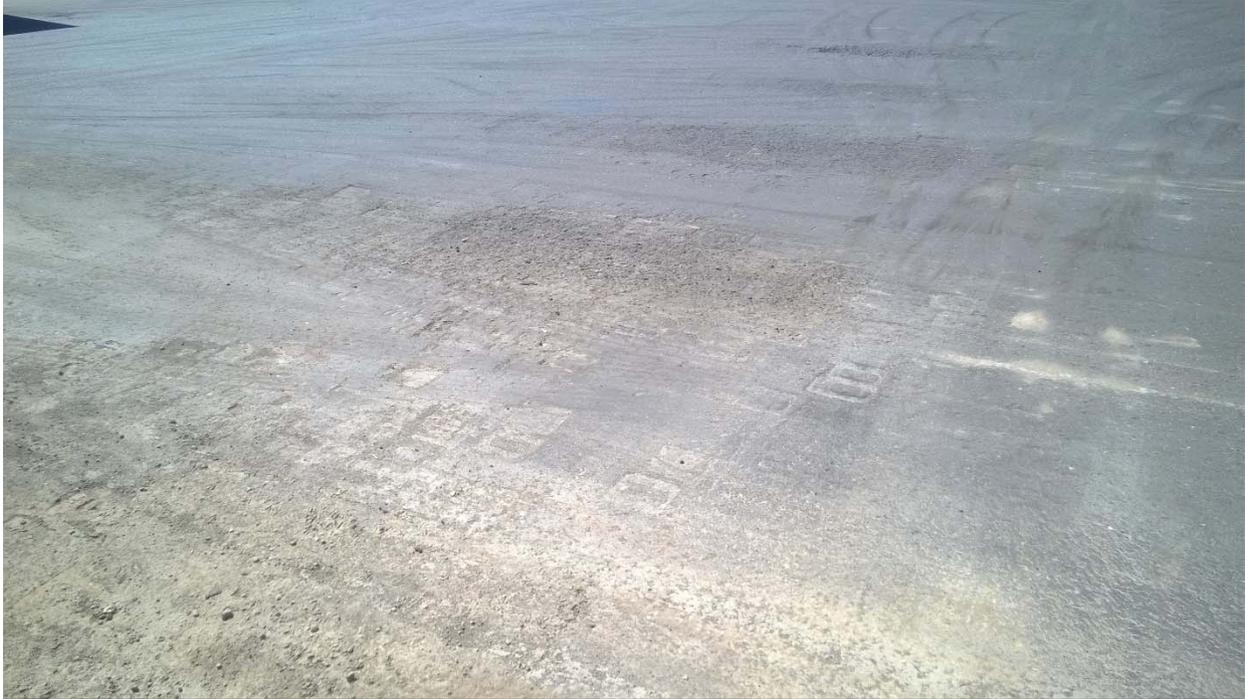
Photo 9: Pavement Conditions

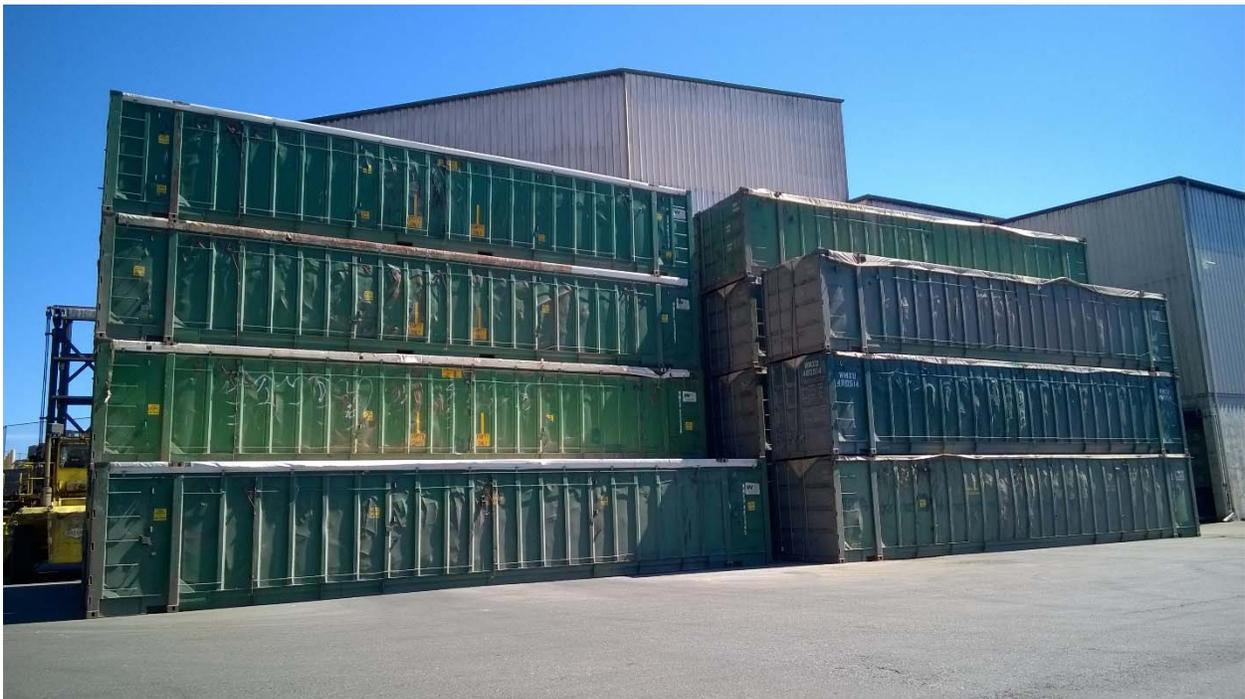
Photo 10: Pavement Conditions, Pre-Packed Area

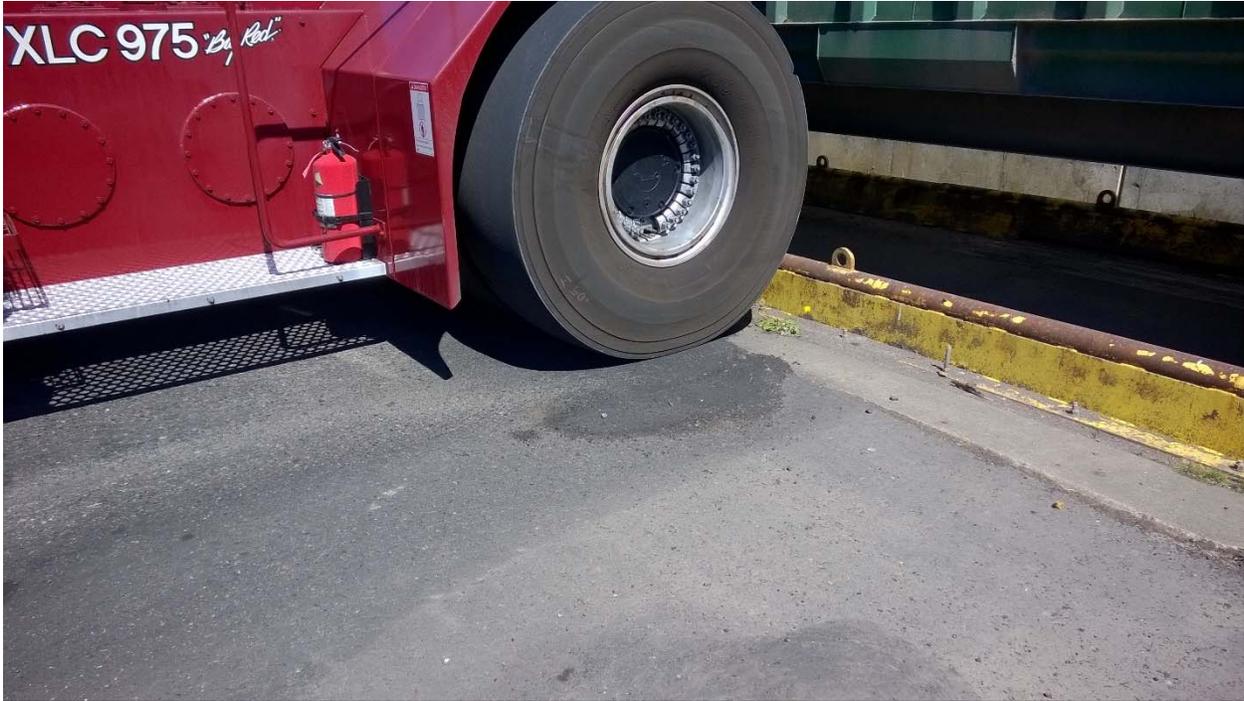
Photo 11: Pavement Conditions

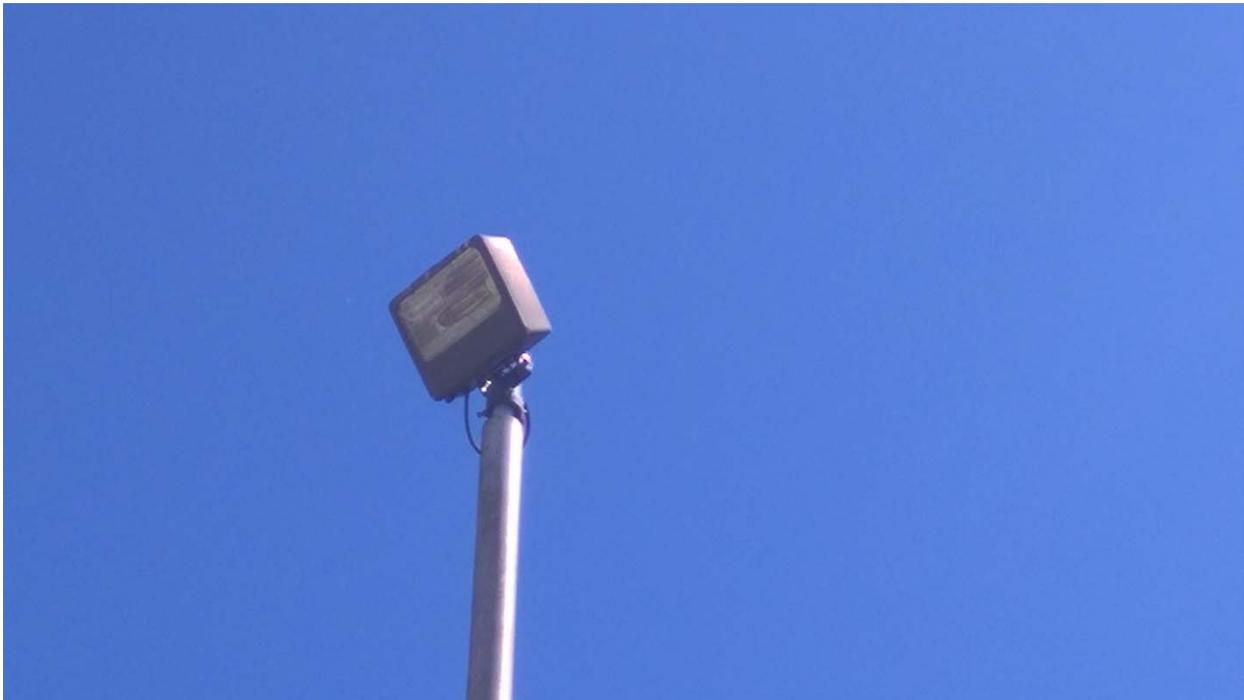
Photo 12: Non-LED Luminaries

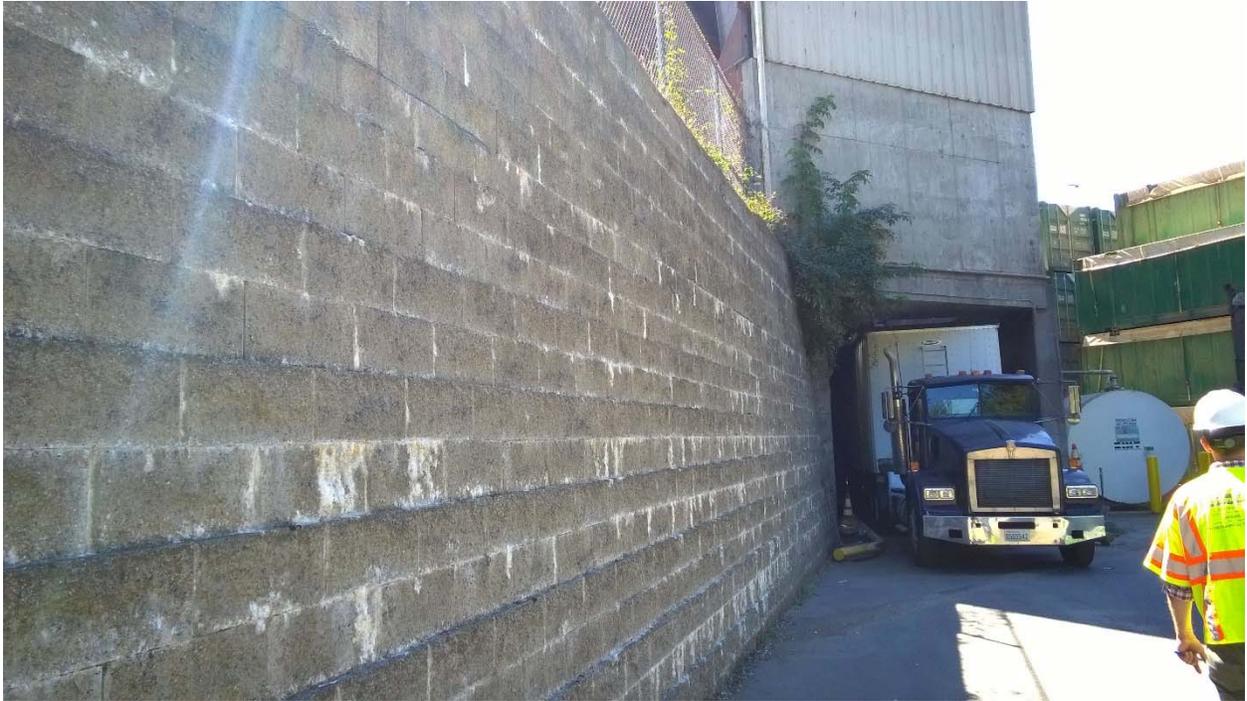
Photo 13: Wall Vegetation

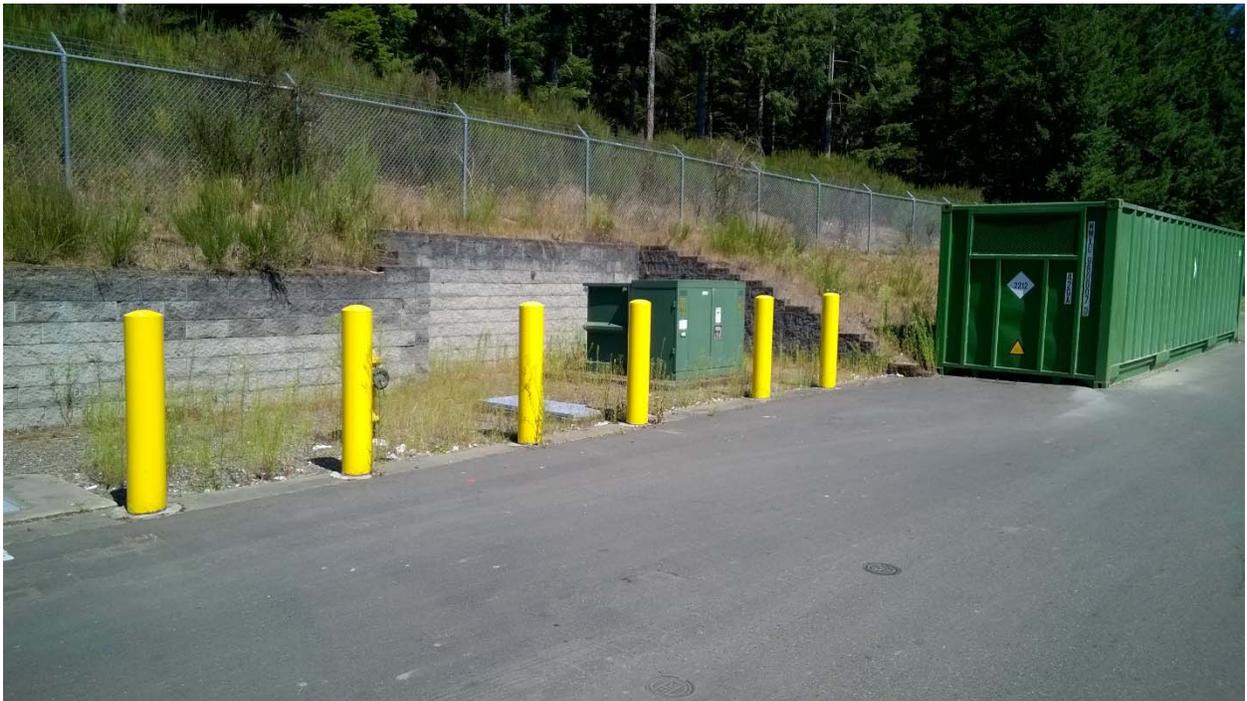
Photo 14: Vegetation in Gravel

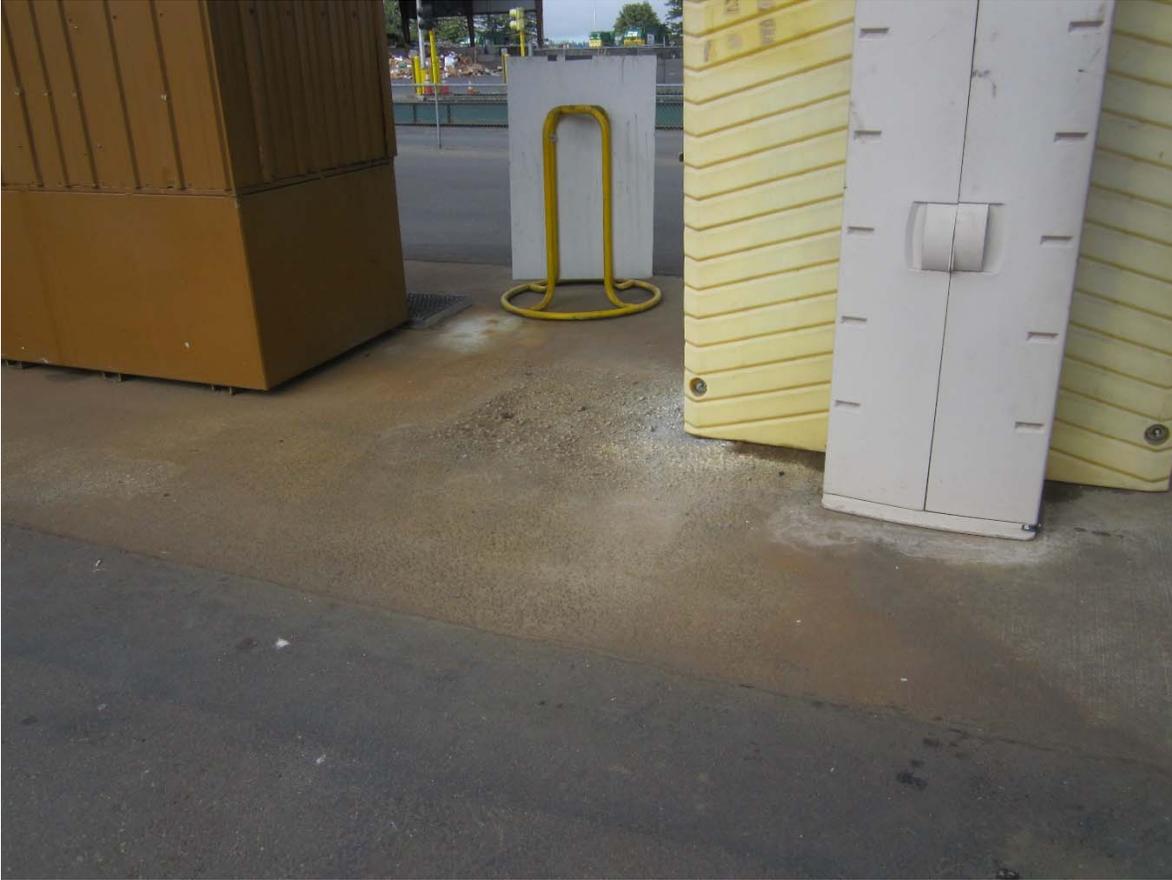
Photo 1: Slab Deterioration

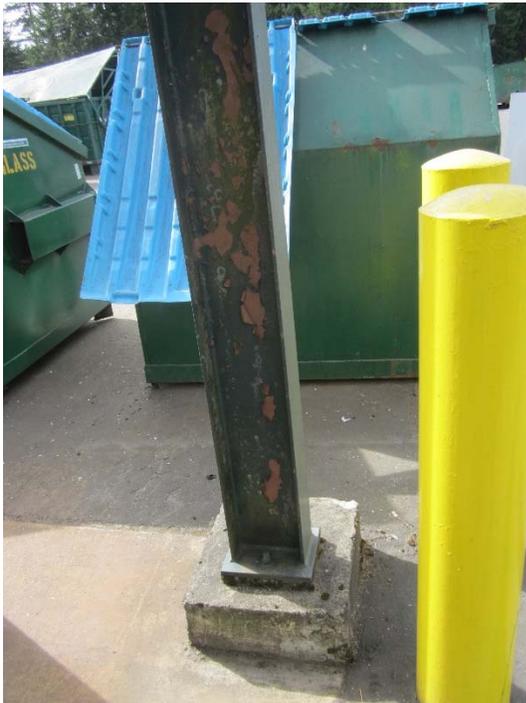
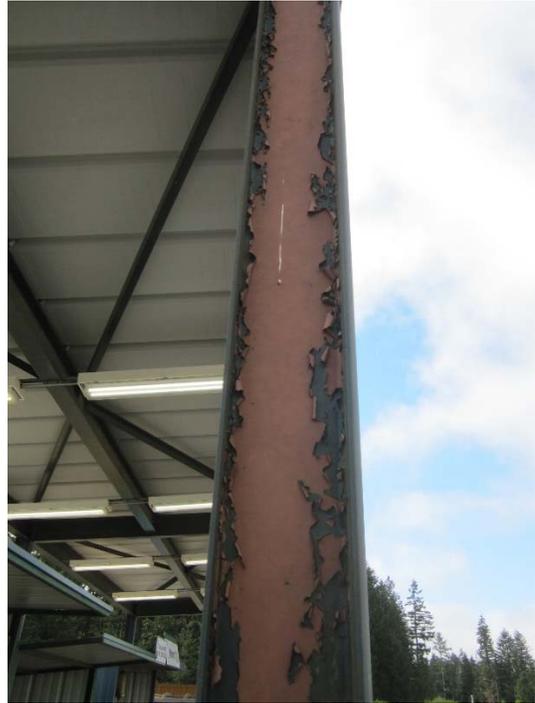
Photos 2 and 3: Paint/Coating Failure

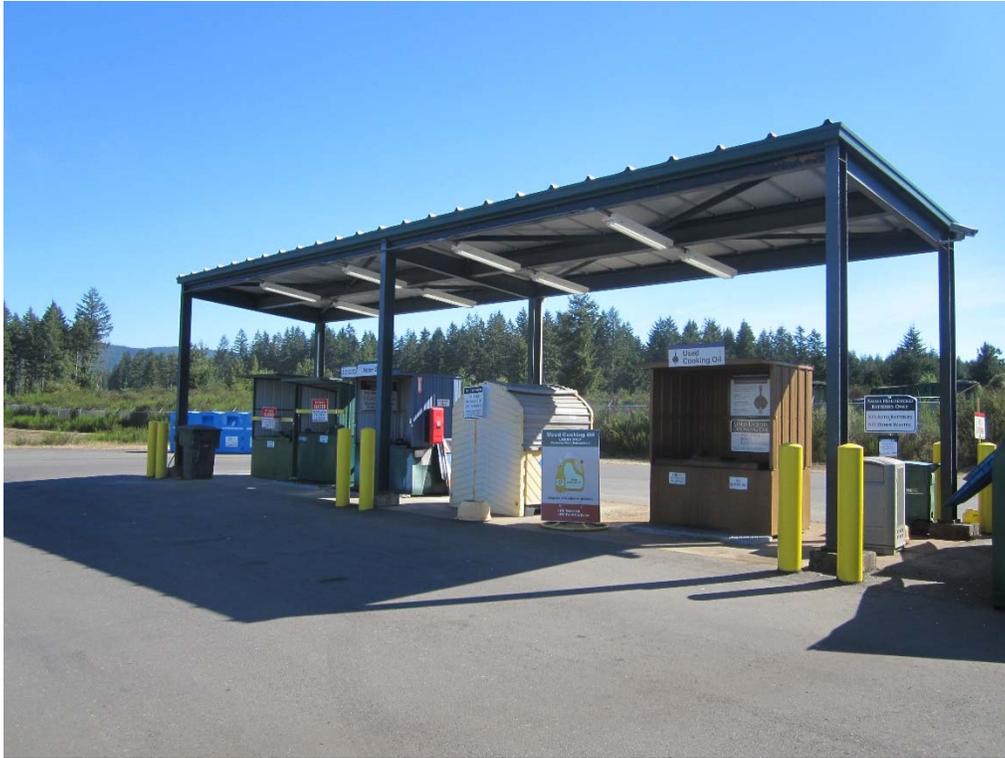
Photo 4: New LED Fixtures

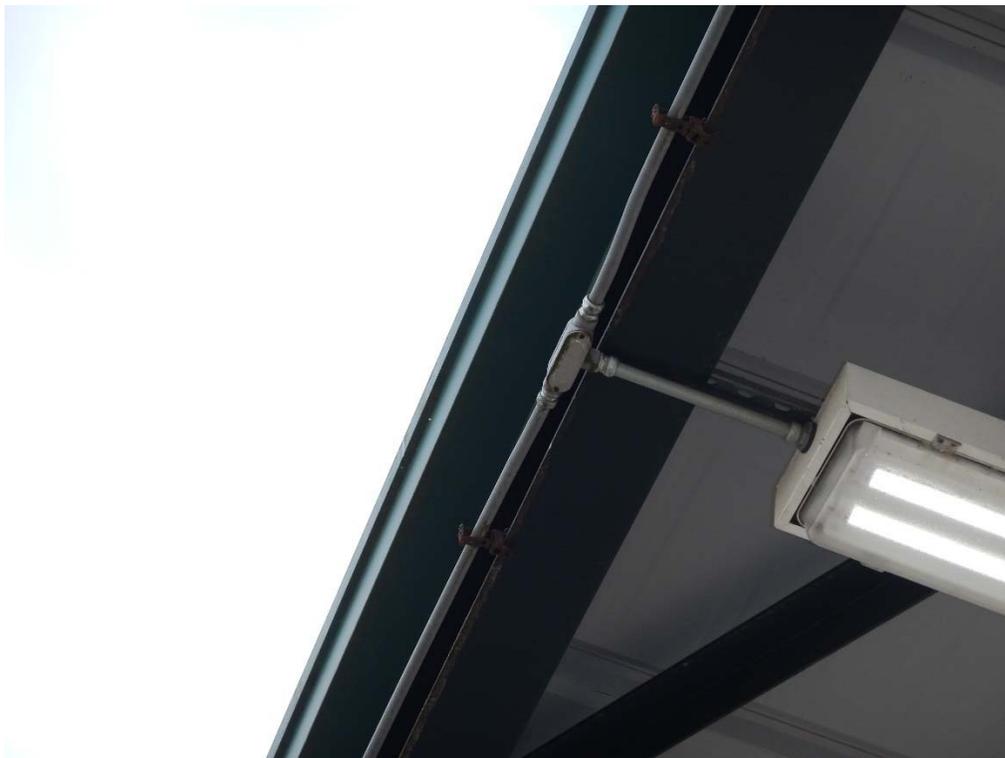
Photo 5: Rusted Conduit Clamps

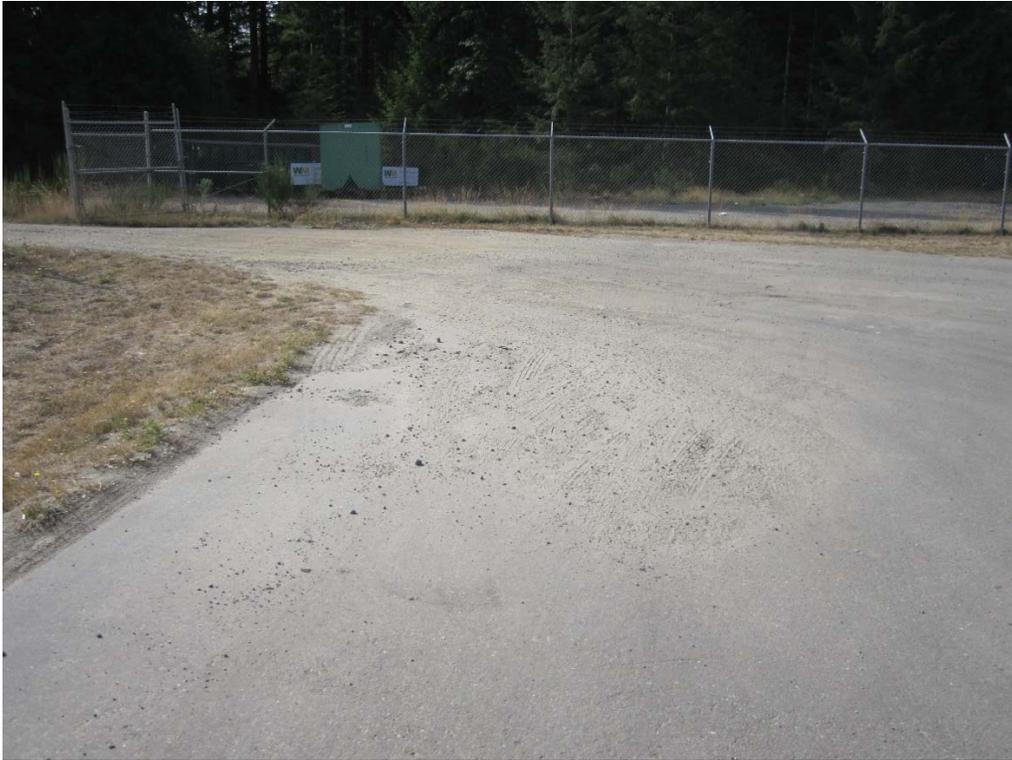
Photo 6: Southeast Corner Dirt and Gravel

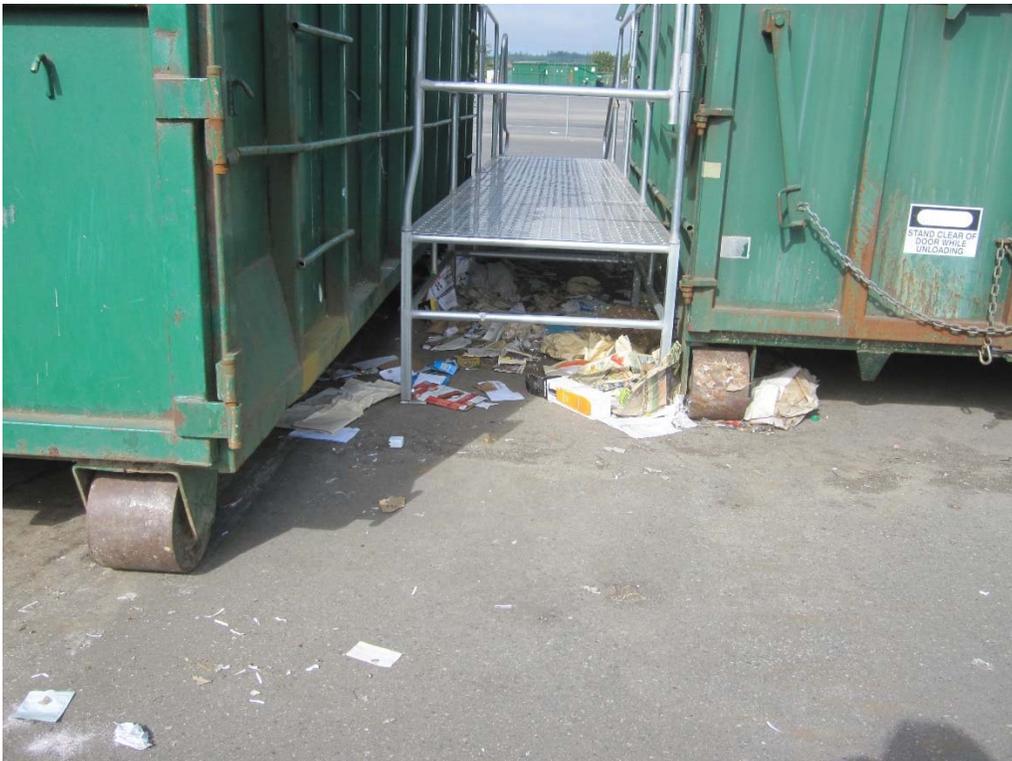
Photo 7: Container and Ramp Litter

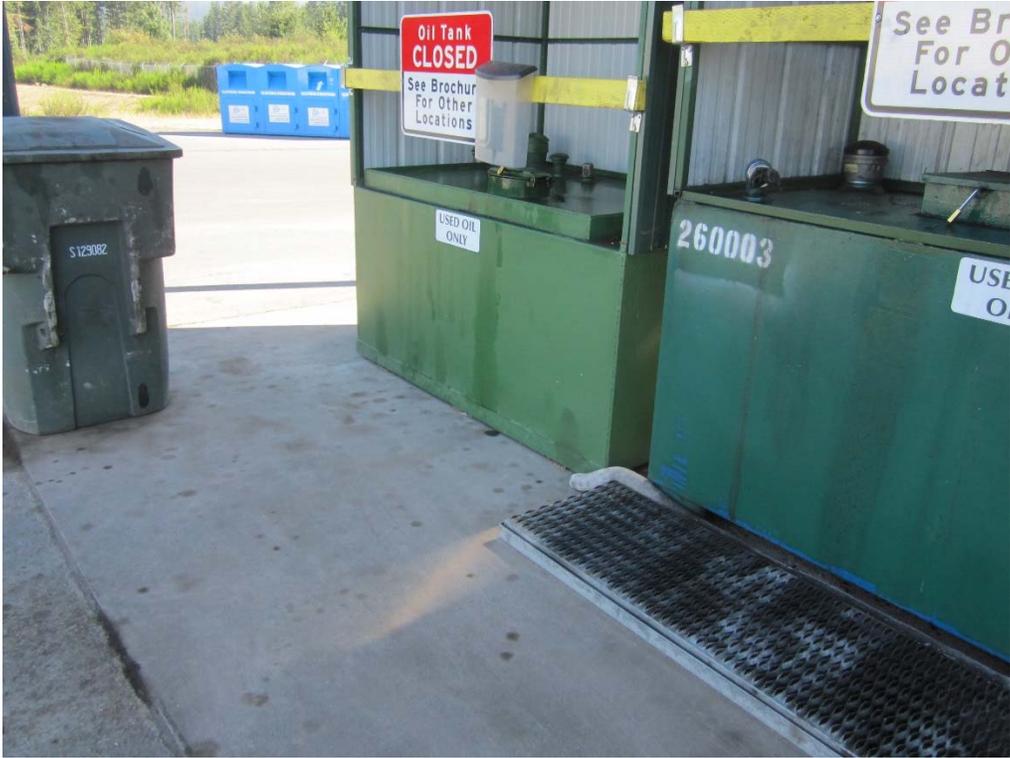
Bollards	KH, IS	✓		
Containers and Ramps <ul style="list-style-type: none"> - All but one ramp was replaced since last inspection. Remaining old ramp is worn and missing a middle end rail - On new ramps a total of 5 handrail splice brackets are missing and have been replaced with plastic zip ties and one stair handrail has been damaged and bent - Area around containers and ramps need to be cleaned and have excessive litter; see Photo 7 - Some oil disposal containers are either missing the spill containment mat or the mats have been damaged and are ineffective; see Photos 8 and 9 	KH, IS, JR		✓	
Spill Kit	KH, IS	✓

Photo 8: Missing Spill Containment Mat

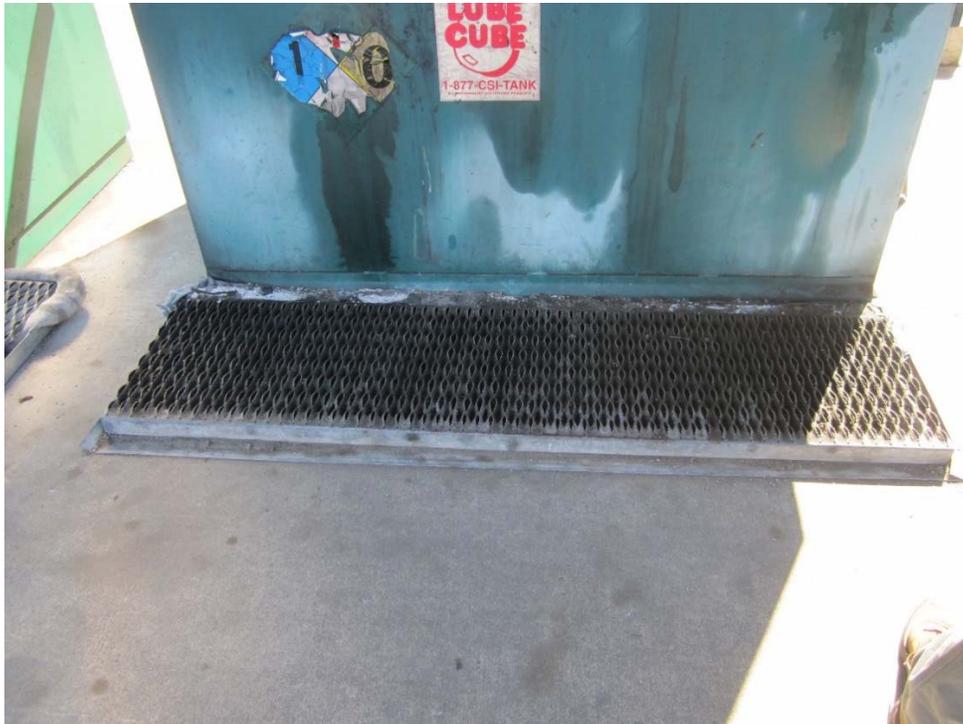
Photo 9: Damaged Spill Containment Mat

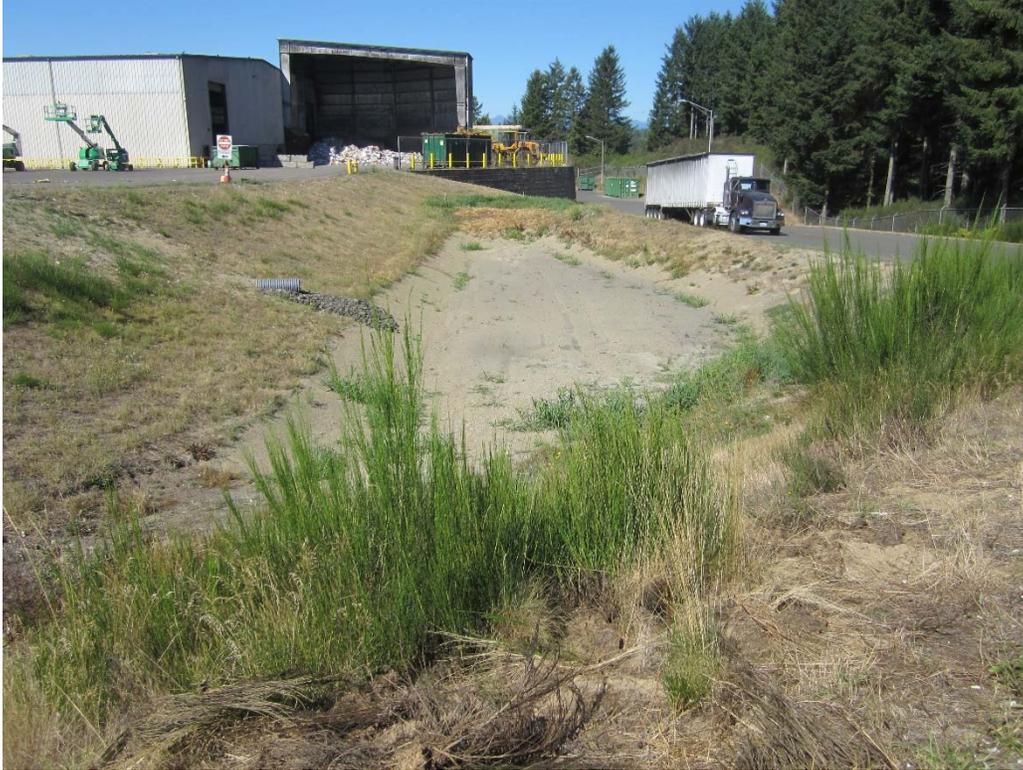
Photo 1: Pond D Bottom

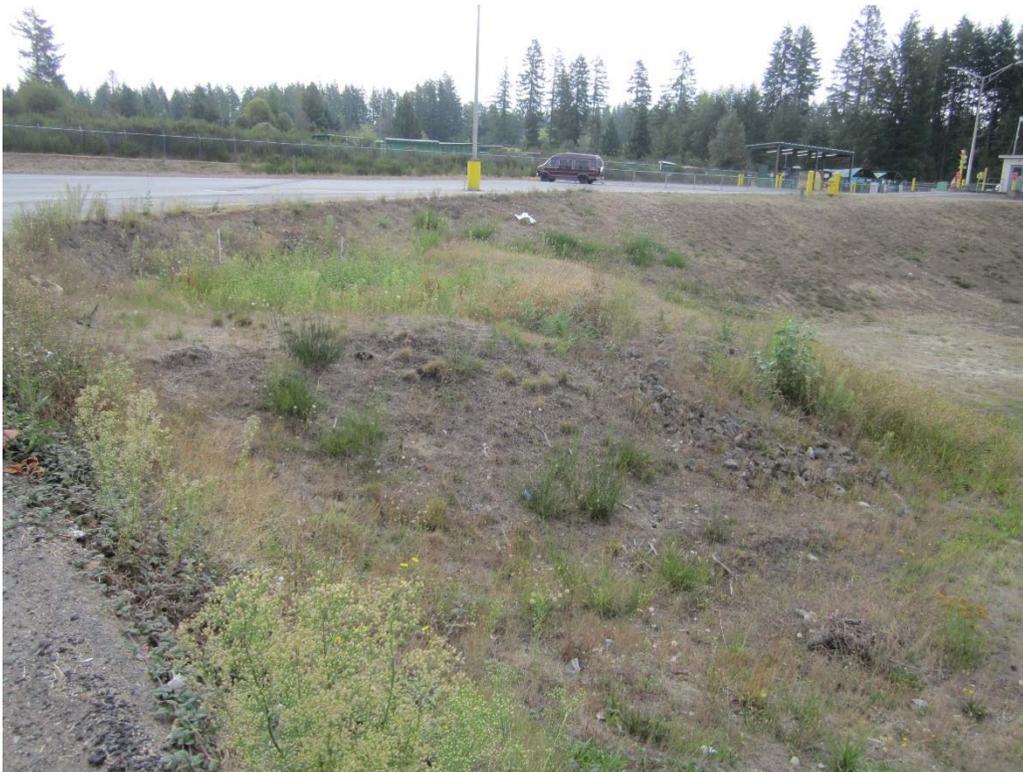
Photo 2: Blocked and Overgrown Riprap Filter Berm

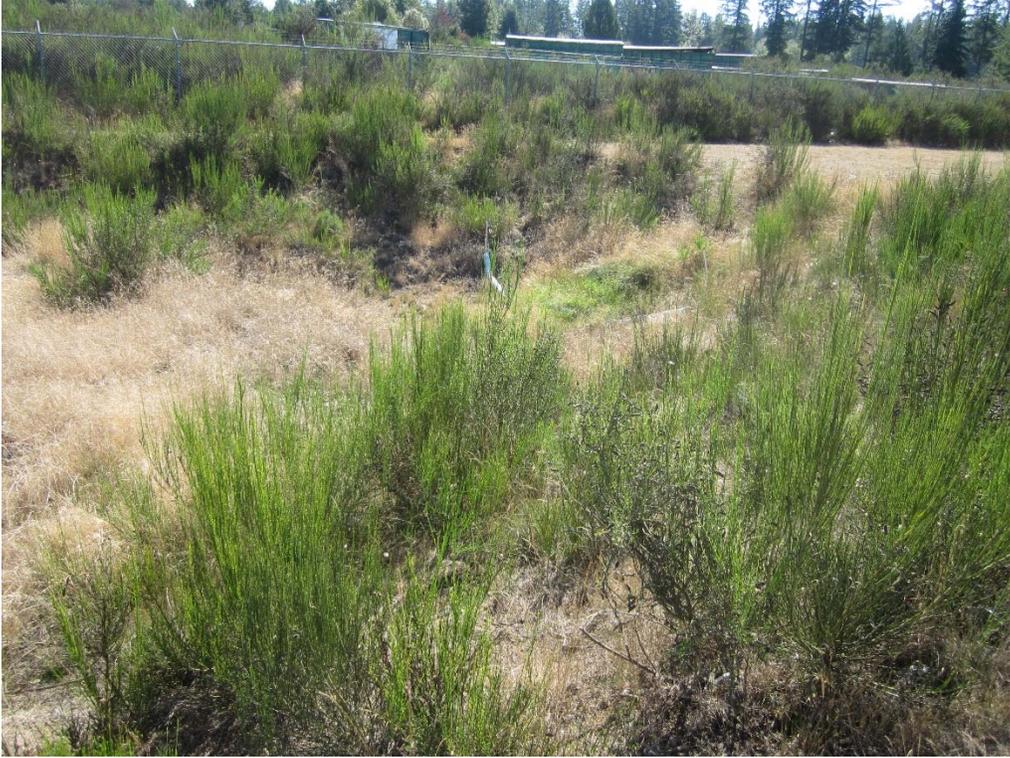
Photo 3: Invasive Pond Vegetation
