Olympic View Transfer Station Findings for Conditions Inspection Report

Kitsap County

Parametrix, Inc. (PMX) completed a visual facility inspection of the Olympic View Transfer Station (OVTS) on August 16, 2016, as part of the Kitsap County Solid Waste Division (County) biennial facility inspection program. The facility inspection of the OVTS, operated by Waste Management, Inc. (WM), included the site, facilities, buildings, infrastructure, and fixed and mobile County-owned equipment. This inspection report reflects the condition of the facility at the time of the inspection.

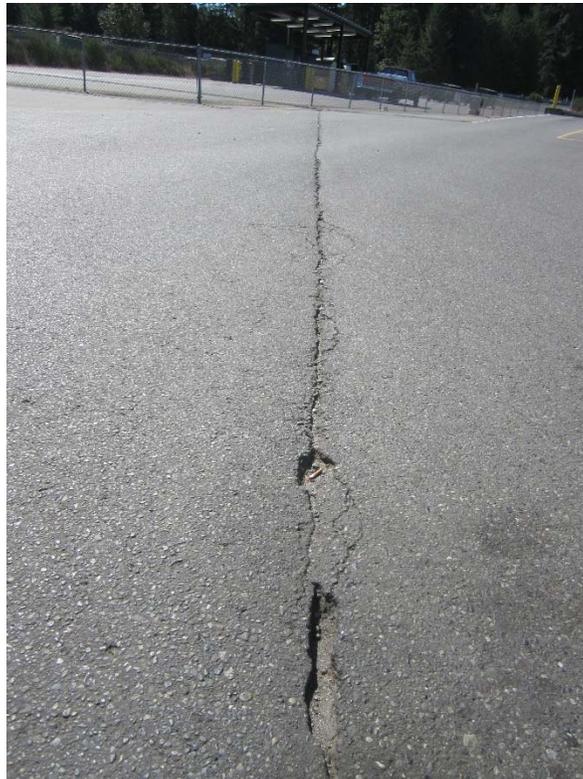
Photo 4: Pavement Cracks

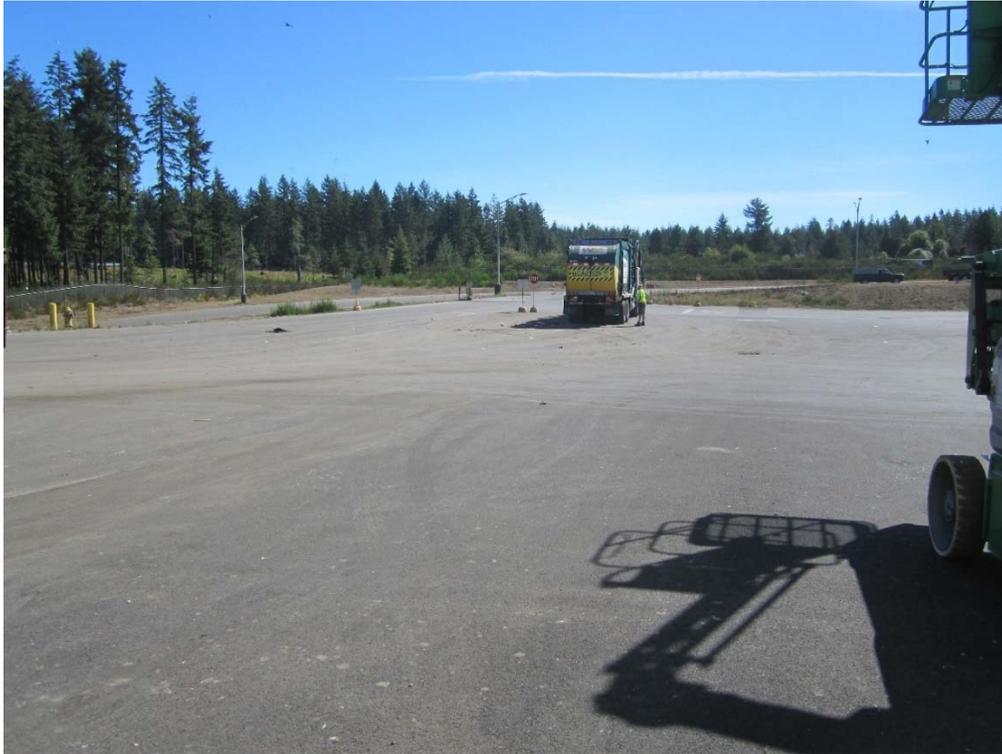
Photo 5: Litter and Vector Attraction

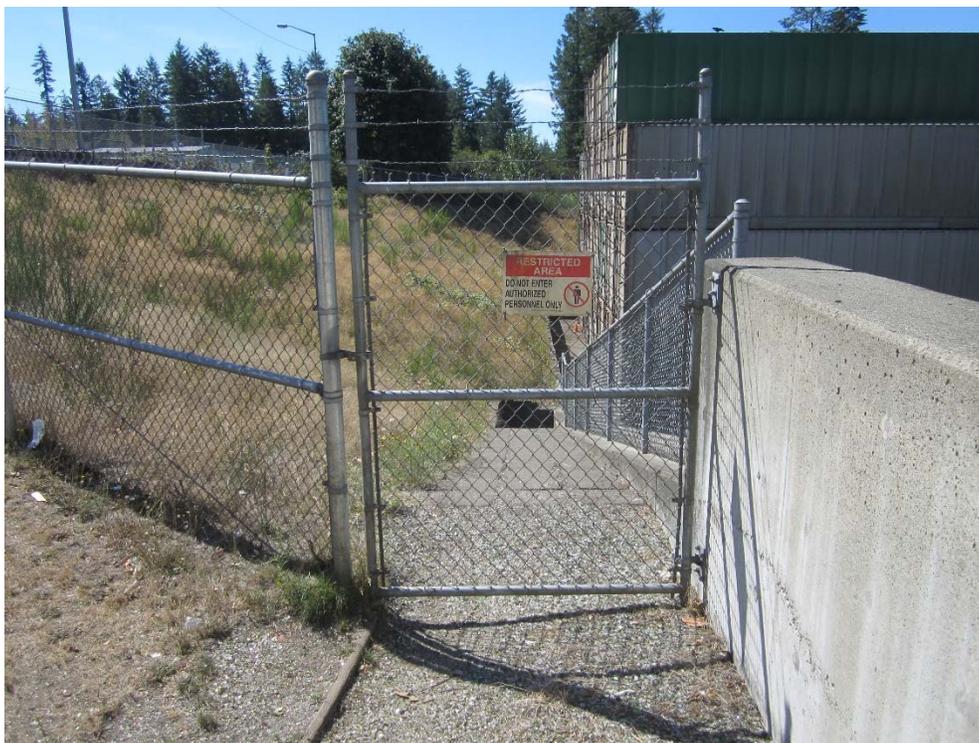
Photo 6: Stairs to the Intermodal/Rail Yard
