Harper Park Footbridge Limited Geotechnical Report

Prepared for:
Kitsap County Parks Department

Prepared by:
PND Engineers, Inc.
1736 Fourth Ave S
Seattle, WA 98134

March 9, 2020

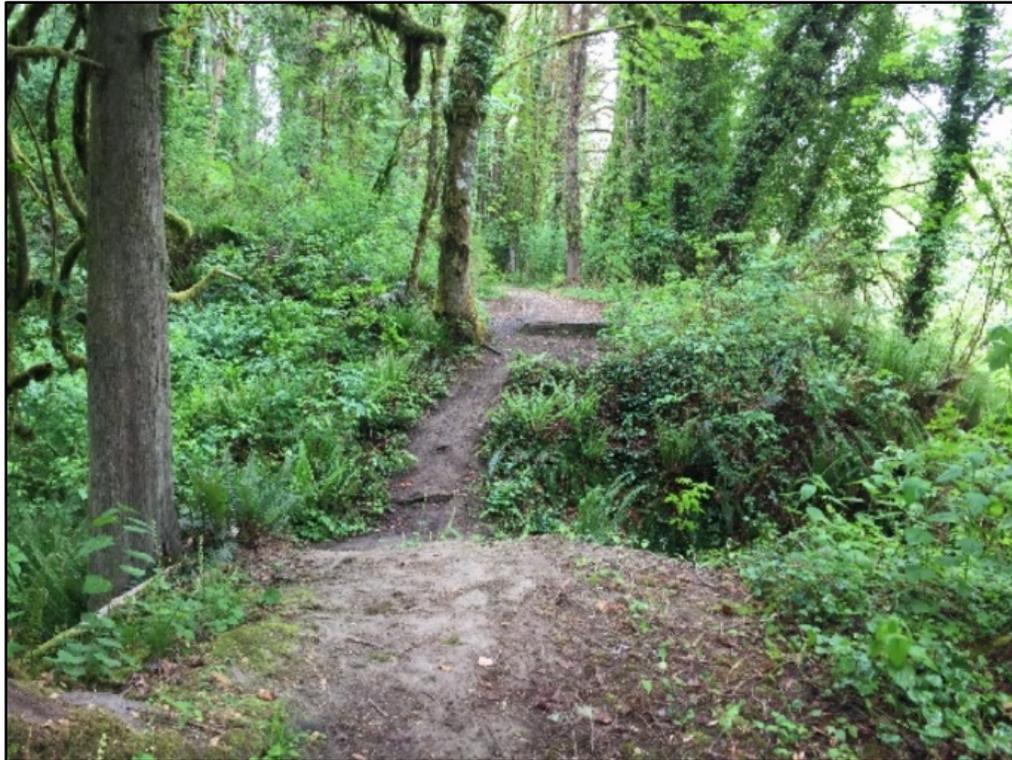
Figure 2-1: Footbridge site, looking north

Approximately 600 feet south of the parking lot, the railway bed crosses the mouth of a ravine that opens to the east. The length of the embankment across the ravine, as judged by the subsequent topographic survey, is about 60 feet. An intermittent stream flows to the east through a skewed 18-inch-diameter concrete culvert, which the trail currently passes over. The embankment is heavily vegetated, except on the walking pathway. Mature cedars, maples, and alders are established along the sides of the embankment.

During the site visit, no subsurface explorations were made, nor samples collected for laboratory testing. Visual observations indicated that the railroad embankment consists of compacted sand and gravel fill.

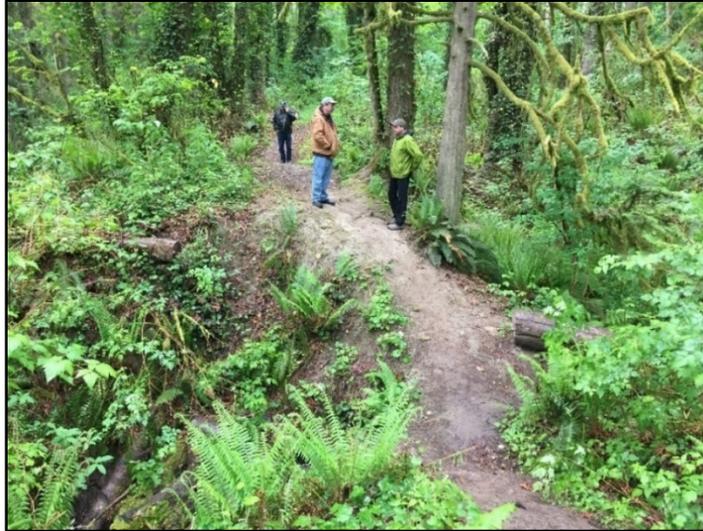
Figure 2-2: Footbridge site, looking south

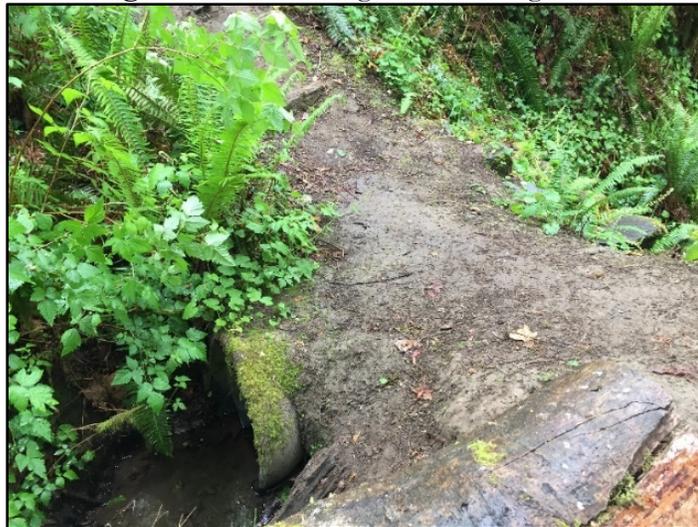
Figure 2-3: Existing culvert inlet

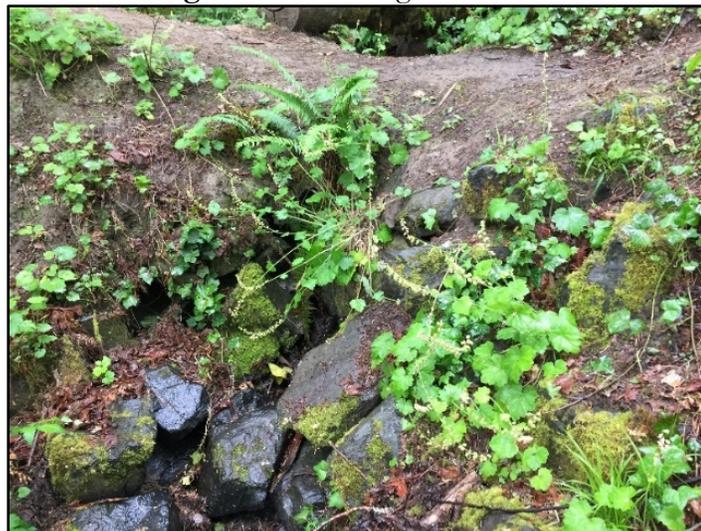
Figure 2-4: Existing culvert outlet

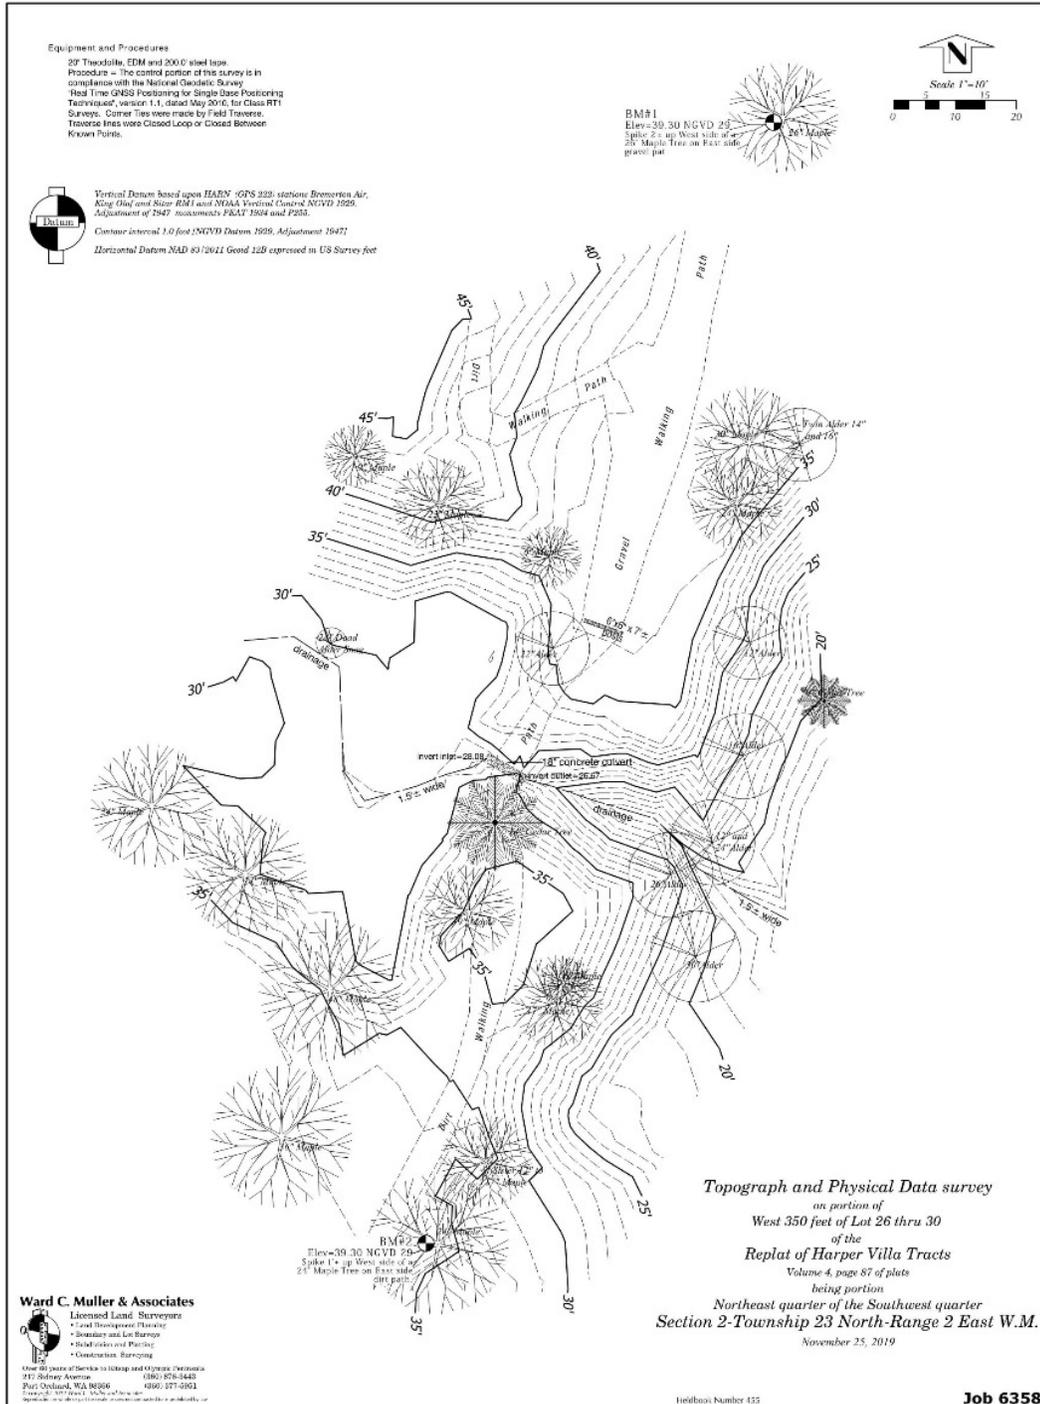
Ward C. Muller & Associates of Port Orchard conducted a topographic survey of the vicinity surrounding the footbridge location in November 2019. The survey provided a base map drawing that was used for the footbridge positioning, as shown in the permit drawings in Appendix A.

Figure 2-1: Topographic Survey for footbridge.

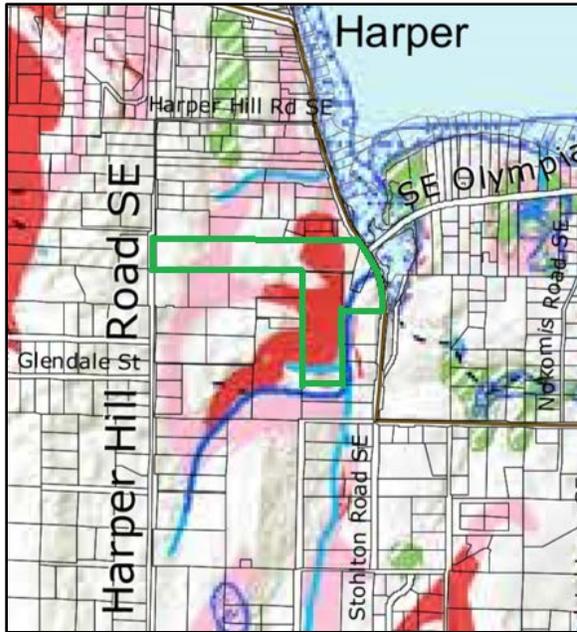
Geologically Hazardous Areas

High Geological Hazard Areas described:

Areas of HIGH EROSION HAZARD:

- a. Channel Migration Zones, as mapped by the Washington Department of Ecology;
- b. Coastal erosion with a sediment source rating value of 0.6 to 1.0, per the Prioritization Analysis of Sediment Sources in Kitsap County

Areas of HIGH LANDSLIDE HAZARD.

- a. Shallow landslide areas with Factor of Safety (FS) of 0.5 to 1.5. FS is a method (Harp, 2006) for slope stability based on the angle of the slope from LiDAR elevation data and strength parameters.
- b. Areas with slopes greater to or equal to 30 percent in grade and deemed by a qualified geologist or geotechnical engineer to meet the criteria of U, UOS, or URS.
- c. All deep-seated landslides areas.

Figure 3-1: Harper Park, outlined in green, superimposed on the Critical Areas map.

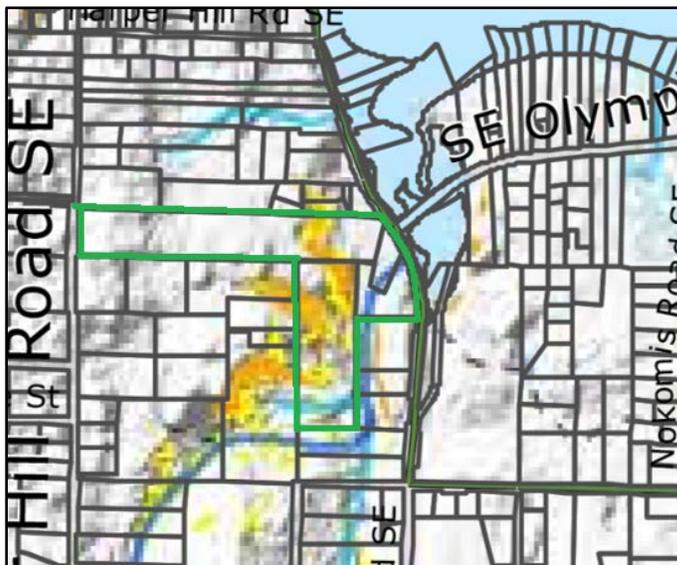
Geologically Hazardous Map
LANDSLIDE HAZARDS
KITSAP COUNTY
 Washington

Figure 3-2: Harper Park, outlined in green, superimposed on the Landslide Hazards map.
