Olympic View Transfer Station Findings for Conditions Inspection Report

Kitsap County

Parametrix, Inc. (PMX) completed a visual facility inspection of the Olympic View Transfer Station (OVTS) on August 16, 2016, as part of the Kitsap County Solid Waste Division (County) biennial facility inspection program. The facility inspection of the OVTS, operated by Waste Management, Inc. (WM), included the site, facilities, buildings, infrastructure, and fixed and mobile County-owned equipment. This inspection report reflects the condition of the facility at the time of the inspection.

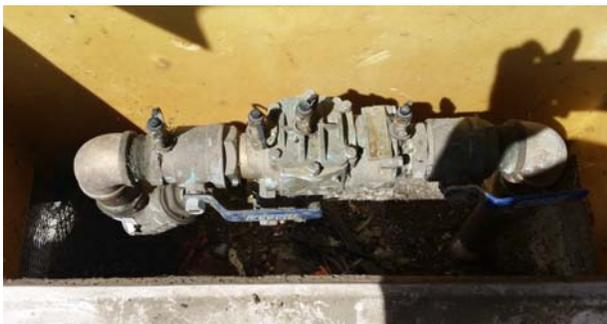
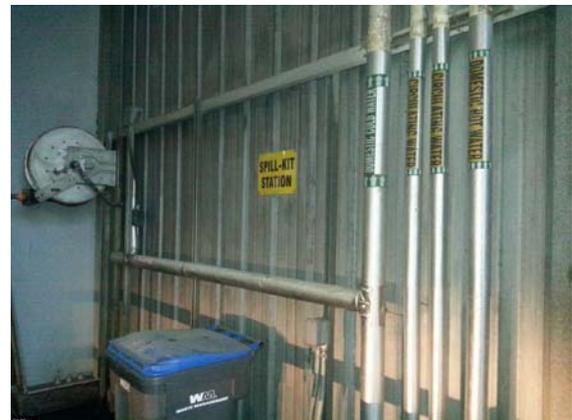
Photos 7 and 8: Potable and Non-Potable Water

<ul style="list-style-type: none"> • Emergency Eyewash and Showers, EEW-1 South - The emergency eyewash/shower at the south end near the public dumping area is blocked by a container - The eyewash did not have the protective cap closed. There was significant dirt build-up on the eyewash nozzle and on the underside of the cap, showing it is regularly left open. This poses a risk of foreign objects entering the water in case of an emergency. The eyewash should be cleaned and the covers should be kept closed when not in use. 	JR, LS			✓
<p>Non-Potable Water System Piping</p> <ul style="list-style-type: none"> - The Transfer Building has a reduced pressure backflow preventer to protect the public water system; however, the potable water and non-potable water are not separated. The piping is co-mingled with fire hose streams, emergency shower and eye wash fixtures and hose reels for spray down of the Transfer Building Floor. The current arrangement is not code-compliant per Uniform Plumbing Code (UPC) Chapter 6, Sections 602.0 – Unlawful Connections and 603.0 – Cross Connection Control and Washington Administrative Code (WAC) 246-290-490 and does pose a backflow hazard to the potable onsite water system, as well as the water supply system serving the facility. See Appendix B for code requirements. This should be addressed as a high public health risk; see Photos 7 and 8. 	LS			✓

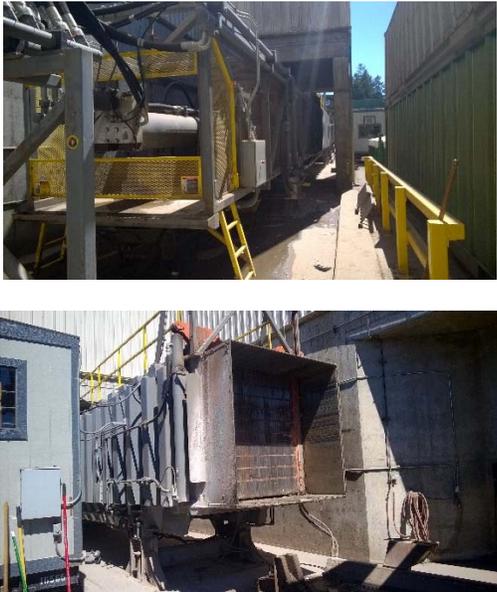
Equipment	Inspector	Overall Condition		
		Good	Fair	Poor
<p>Compactor</p> <ul style="list-style-type: none"> - Not operated during inspection

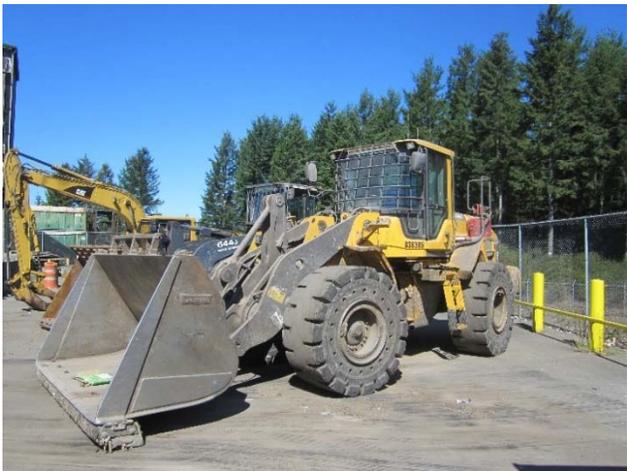
IS	✓		
<p>Volvo Loader 839385</p> <ul style="list-style-type: none"> - Not located on site for the 2014 inspection. Not operated during inspection.

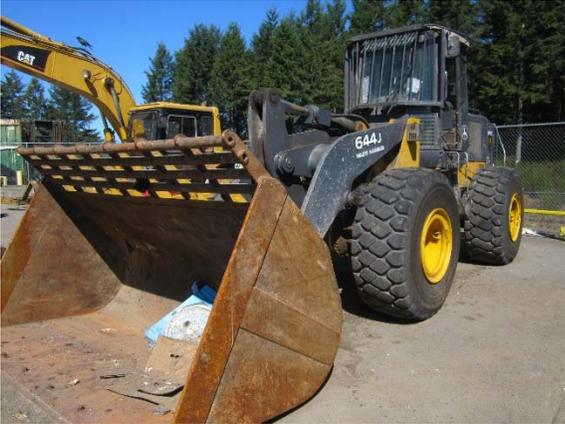
<p>Cat 938 Floor Loader 836258</p> <ul style="list-style-type: none"> - Not located on site during inspection 				
<p>John Deere 644J Floor Loader 839157</p> <ul style="list-style-type: none"> - Not operated during inspection

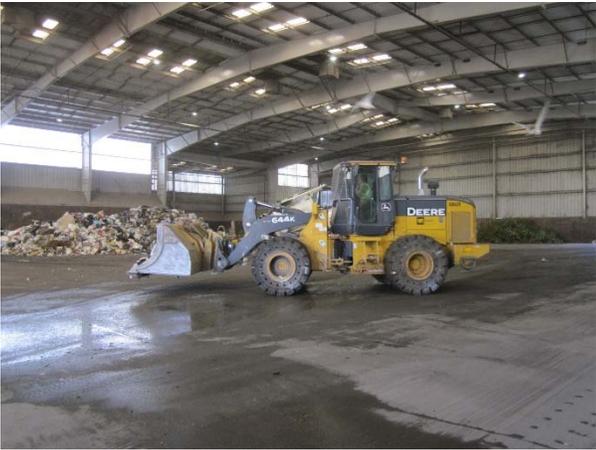
IS	✓		
<p>John Deere 644K Floor Loader 836429</p> <ul style="list-style-type: none"> - Actively operated during inspection. Not onsite for the 2014 inspection.

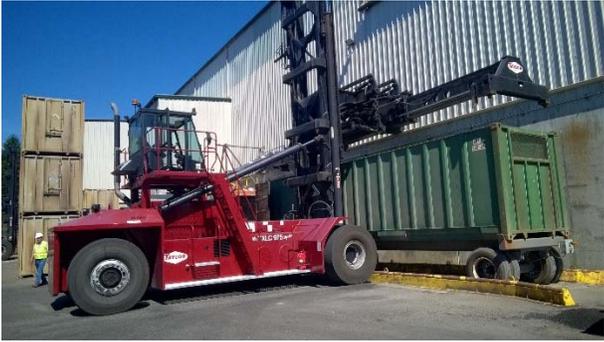
<p>Taylor TXLC 975 861645 - Actively operated during inspection</p>

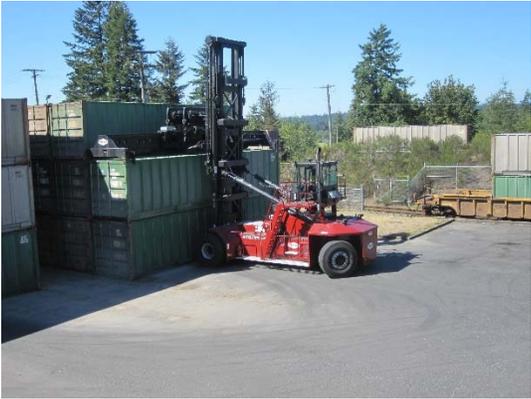
IS	✓		
<p>Taylor TXLC 975 861646 - Actively operated during inspection</p>

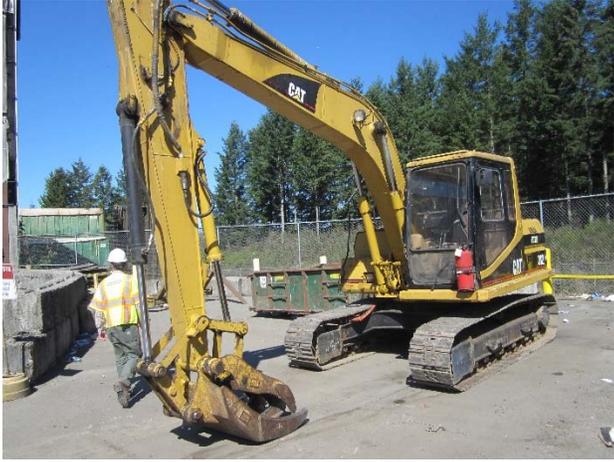
IS	✓		
<p>Cat 308 Excavator 830569 - Not located on site during 2014 or 2016 inspections</p>				
<p>Caterpillar M312 Excavator 830454 - Not operated during inspection</p>

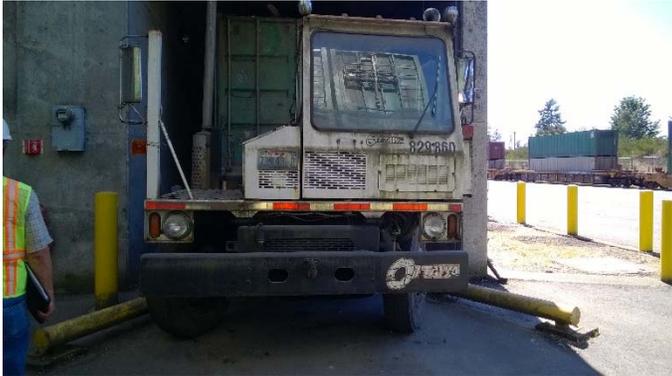
<p>Ottawa Yard Goat 829860</p> <ul style="list-style-type: none"> - Not operated during inspection

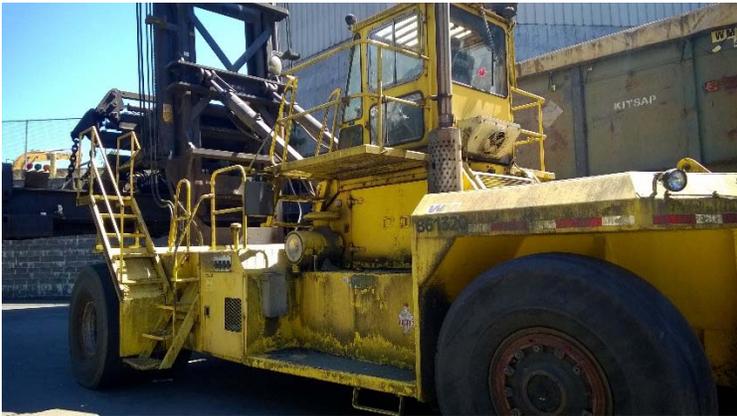
IS		✓	
<p>CAT 924G 835319</p> <ul style="list-style-type: none"> - Not located on site during inspection 				
<p>Taylor 861320</p> <ul style="list-style-type: none"> - Not operated during inspection
